# Conducting Targeted Water Monitoring Studies to Measure Water Quality Success

Steve Hopkins, Nonpoint Source Coordinator  
Iowa Department of Natural Resources  
National NPS Training Workshop  
November 8, 2018

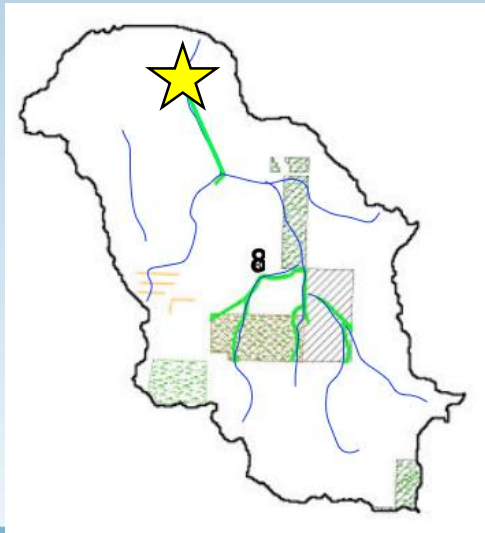
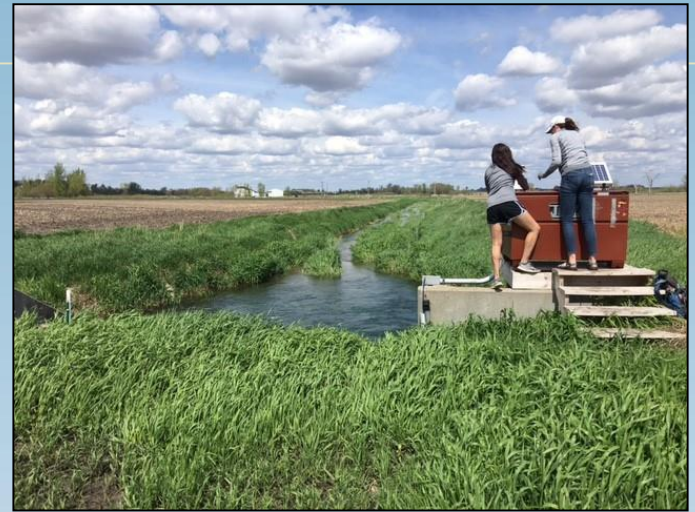
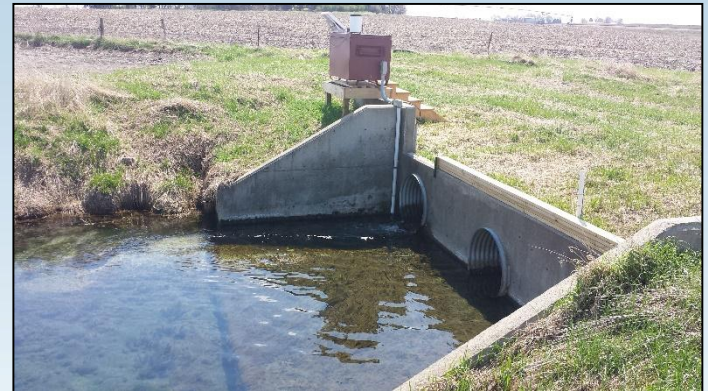
## Subwatershed 8:

- Size: 1,988 acres
- Relatively few BMPs (22.5% of area)
  - Grass waterways, nutrient management, terraces, cover crops.
- 2 Monitoring Locations:
  - 36" tile (site T8)
  - Surface runoff from grass waterway (site S8)

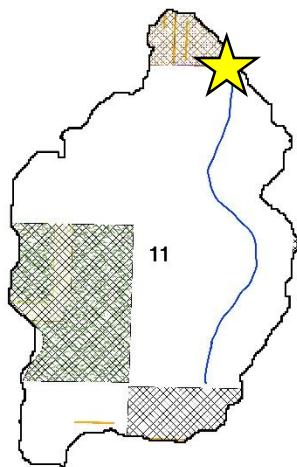
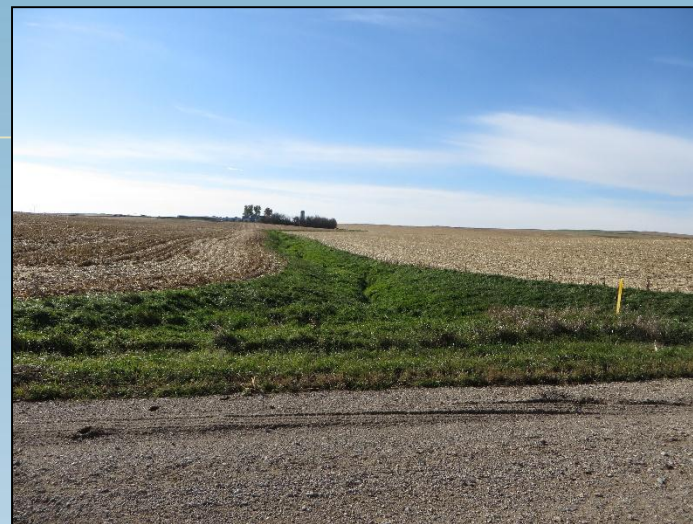
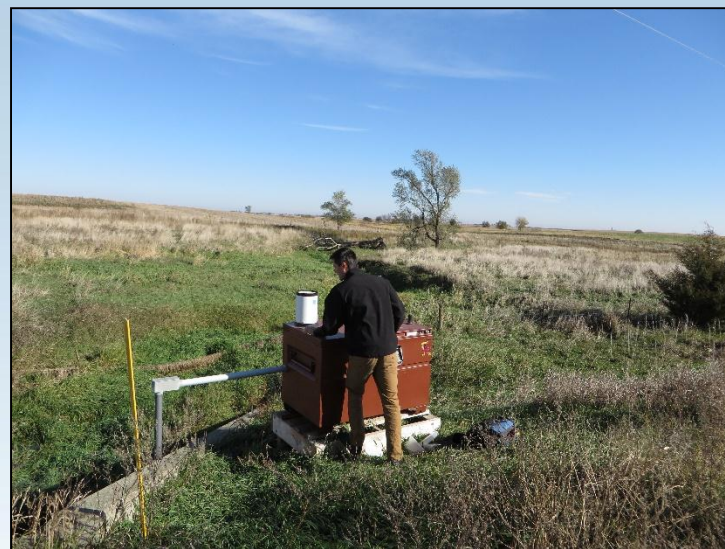
## Subwatershed 11: Low BMPs

- Size: 567 acres.
- Likely tile fed, but access is not possible.
- Some BMP implementation (30% of area), but not near the stream
  - No-till, nutrient management, cover crops.
- 1 Monitoring Location: 1<sup>st</sup> order stream (site S11). CREP wetland is just downstream.

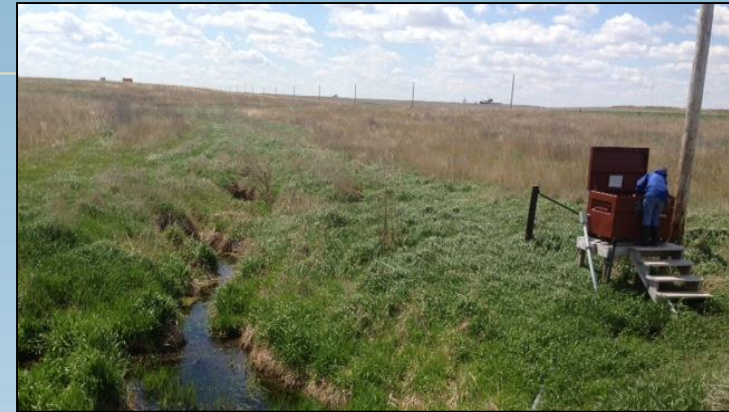
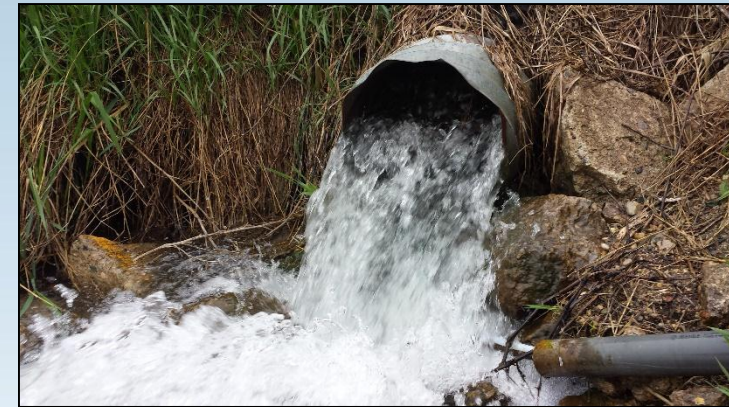
## Subwatershed 12: High BMPs

- Size: 547 acres
- BMP implementation over majority of area (87.5%)
  - Terraces, no-till, nutrient monitoring plans, CRP at surface monitoring point.
- 2 Monitoring Locations:
  - One 15" tile (site T12),
  - One 1<sup>st</sup> order stream (site S12).

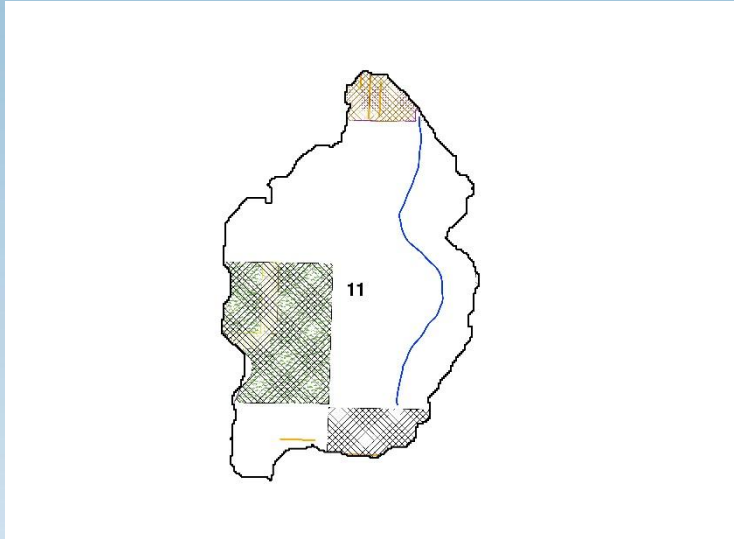
## Subwatershed 11: Low BMP

- Nitrate loss = 279 kg/ha
- TP loss = 3.6 kg/ha
- TSS (Soil loss) = 3,877 kg/ha

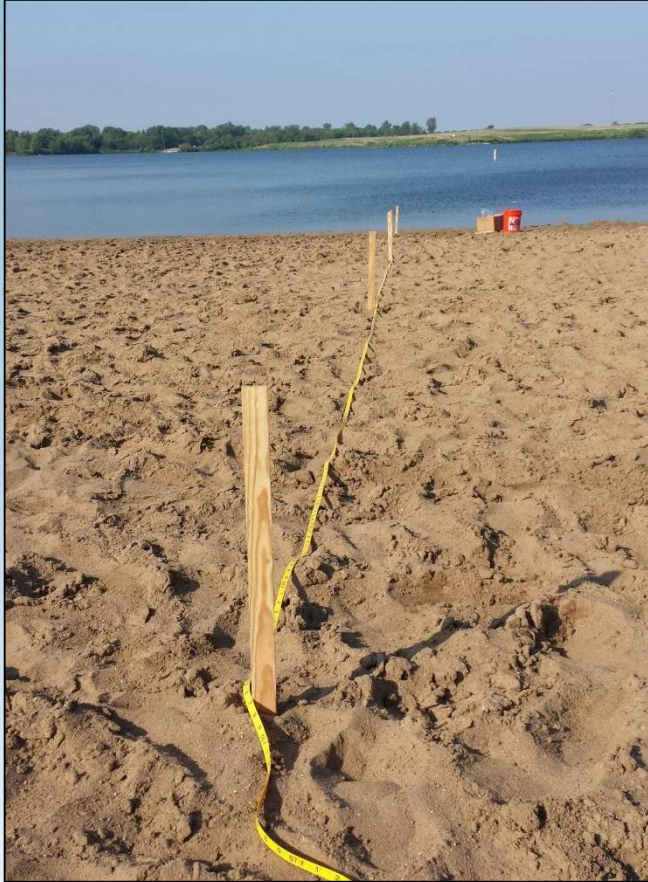
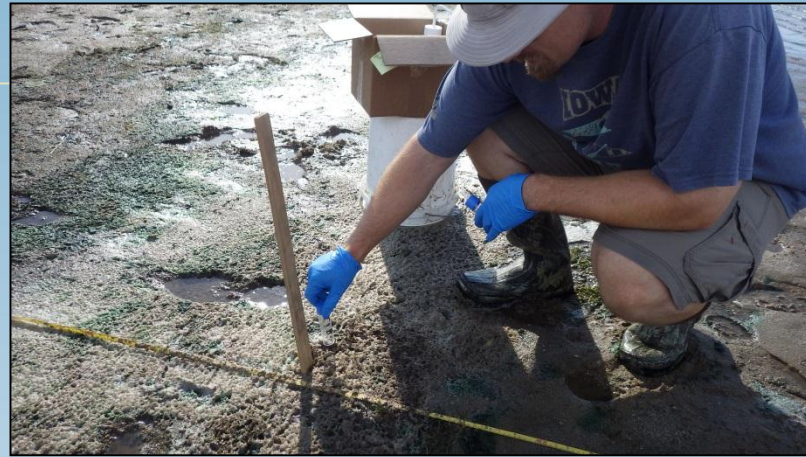
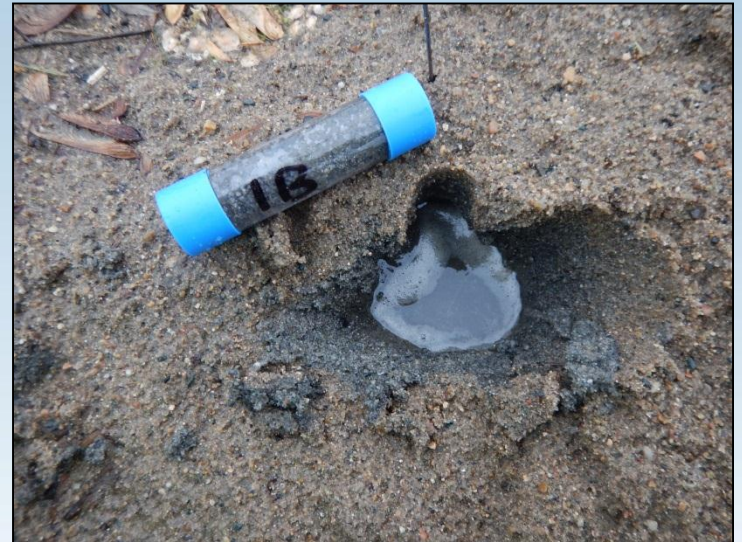
# Sample Collection

Shoreline  
gradient  
Moisture  
E. coli  
100's to  
1,000's  
times  
higher in  
sand than  
water
