LIVING IN KARST

**Iowa Geological Survey
Guidebook Series No. 25**

**IOWA FIELD CONFERENCE FOR PUBLIC POLICY MAKERS
OCTOBER 11-12, 2005**

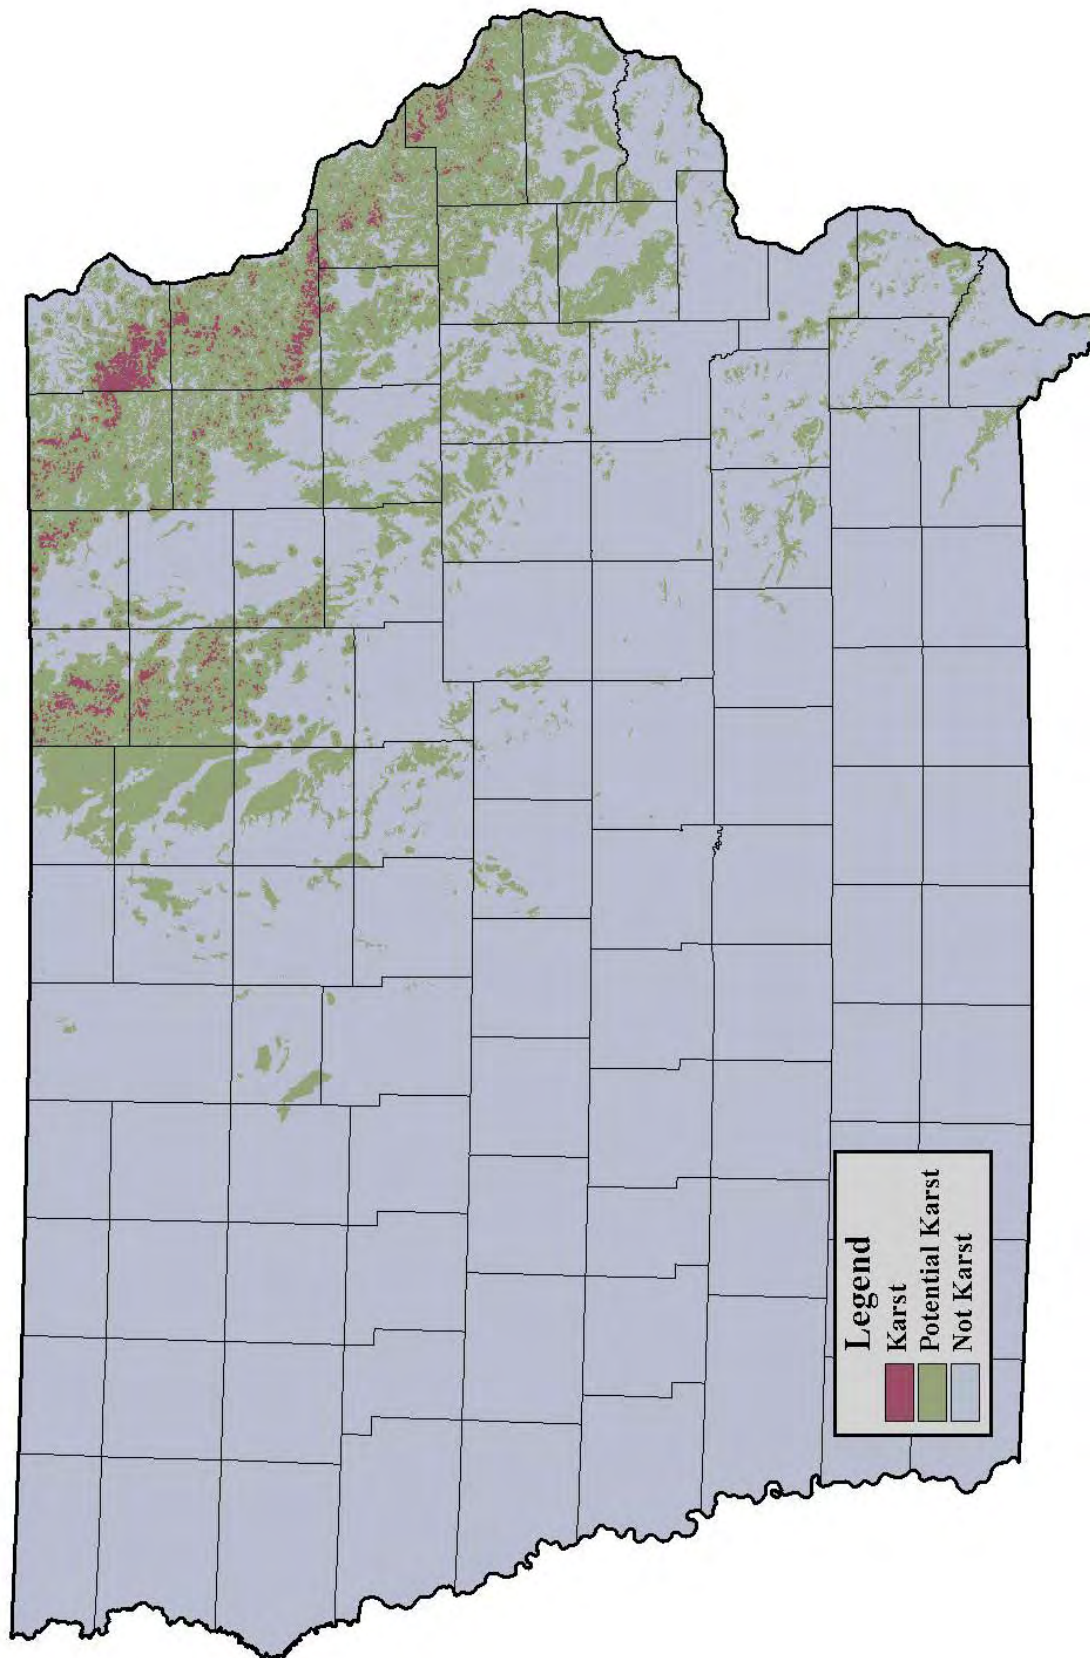
Figure 1. Areas in the state with varying levels of karst development and potential.

Karst conditions affect other parts of the state. Figure 1 shows areas in the state with varying levels of karst development and potential. However, the most visibly developed karst occurs in northeast Iowa. Figure 2 is a generalized stratigraphic column for northeast Iowa, showing the sequence of rocks that underlie the area. Figure 3 is a generalized geologic map showing where the various rock units form the uppermost rock. The unit called the Galena Limestone is the most karst-affected unit. In particular, most of the sinkholes and large springs in this area are formed in this unit. The unit called the Prairie du Chien Dolomite is another carbonate unit that exhibits voids and dissolved fractures, but few sinkholes. We will be referring to the rock column and geologic map throughout the trip to keep ourselves geographically and geologically located.

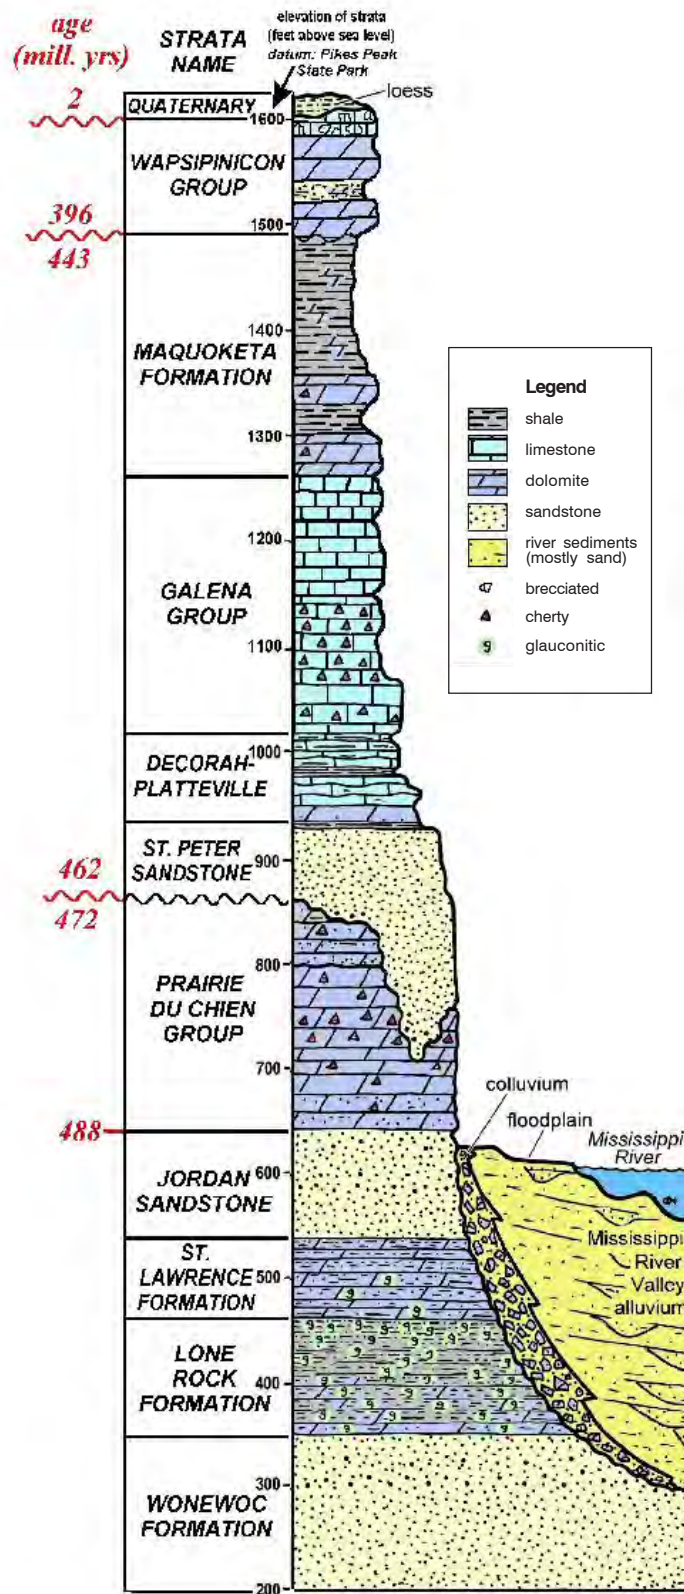
Figure 2. Generalized stratigraphic column of northeast Iowa.

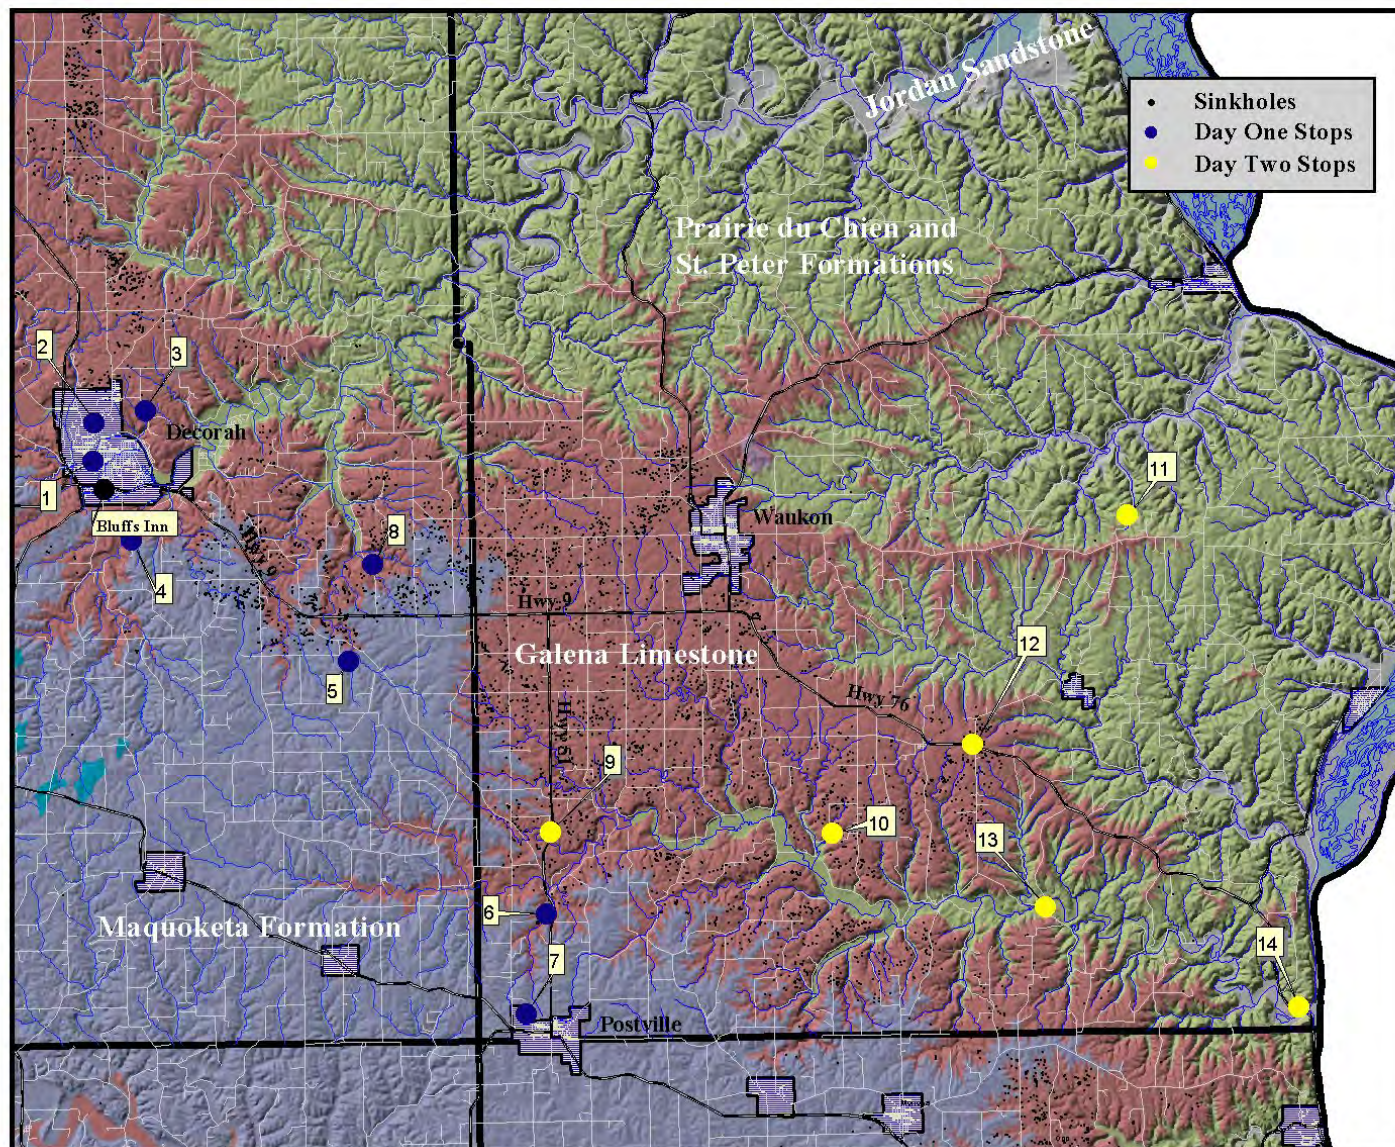
Figure 3. Generalized geologic map of northeast Iowa showing field conference stops.

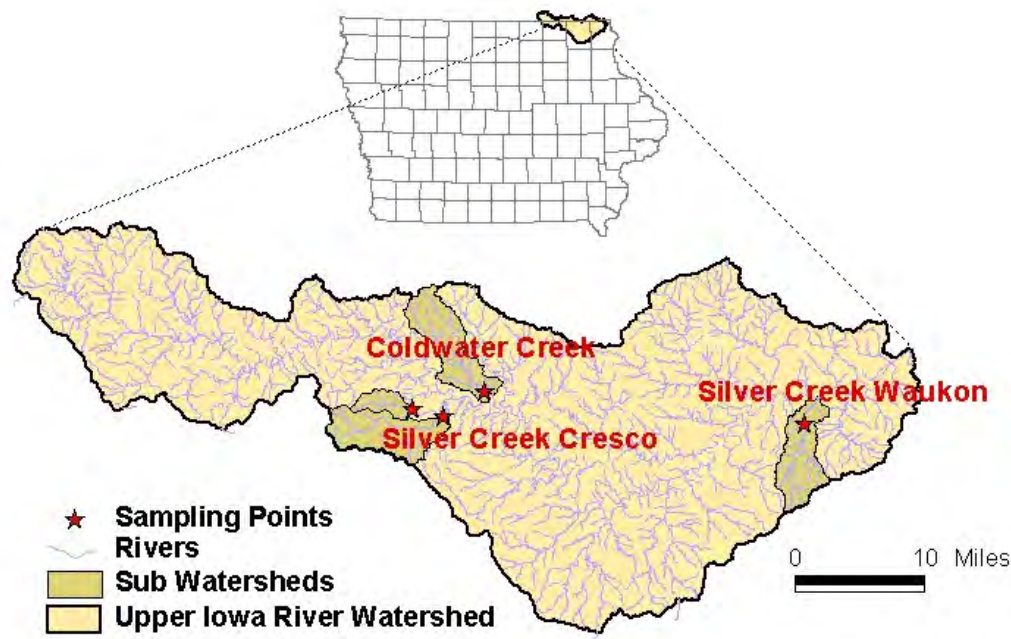
Figure 1-1. Water monitoring locations for DNA source tracking analyses.

The Upper Iowa River Watershed Alliance has monitored 39 stream sites throughout the Upper Iowa River Watershed since 1999 in an effort to identify sub-watersheds that are contributing elevated levels of fecal indicator bacteria to the Upper Iowa River. The water quality monitoring identified six sub-watershed tributaries that had elevated bacteria levels. Three of the six tributaries were selected for a bacteria source tracking project: Coldwater

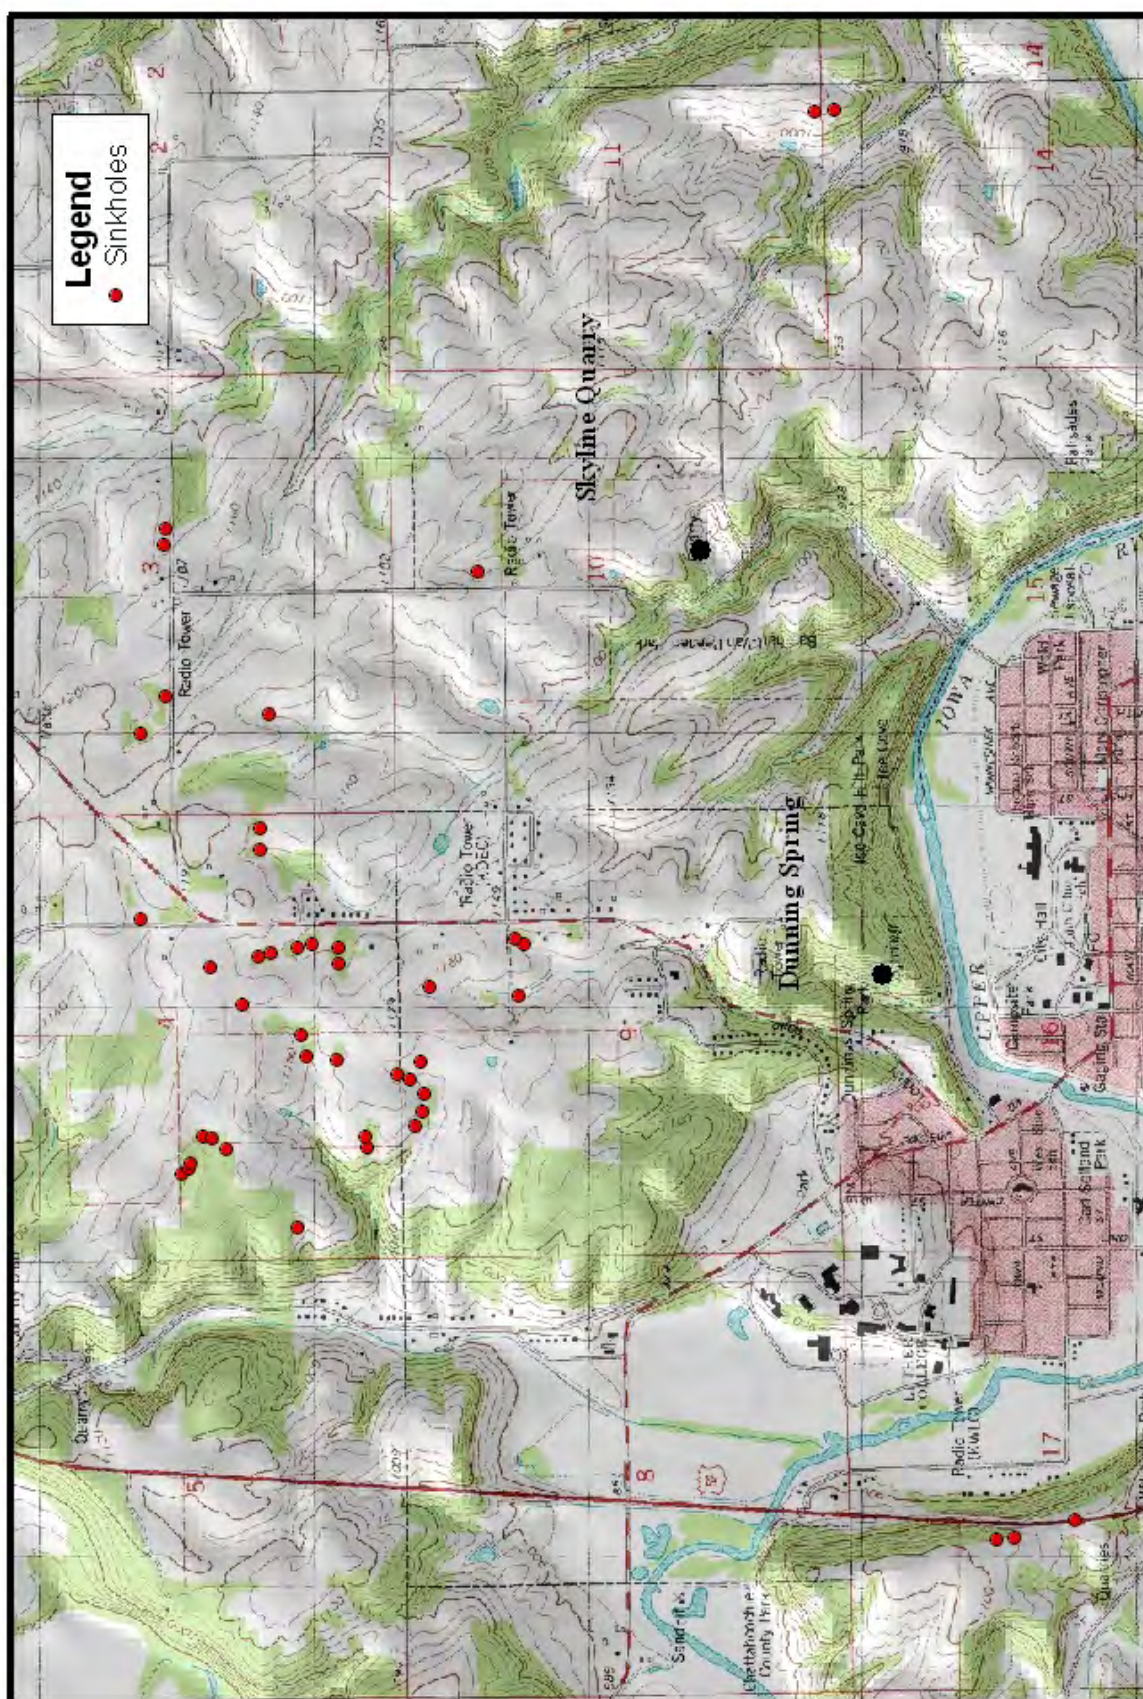
Figure 2-1. Topographic map of Dunning Spring–Skyline Quarry area with sinkholes.

Dunning Spring issues from near the base of the Galena Aquifer. The much less permeable Decorah Shale - the confining bed “floor” for the aquifer - is near the land surface, forcing the water to discharge from the wall of the Upper Iowa River Valley. The result is the picturesque falls. The groundwater issuing from the spring is flowing through an open, cavernous conduit, formed by the solutional enlargement of fractures. Solutionally modified fractures and cracks are the most common characteristic of karst. The water from this (and most larger springs in the area) maintains a fairly constant temperature of about 45 degrees F most of the year. Exceptions occur after snowmelt or heavy rains when colder or warmer water rapidly enters the aquifer via sinkholes and losing streams. About 50 feet below our feet is the contact between the Decorah confining bed and the underlying St. Peter Sandstone. Figure 2-1 shows the area around Dunning Spring, with sinkholes mapped to the north. Our next stop, Skyline Quarry, is also visible.

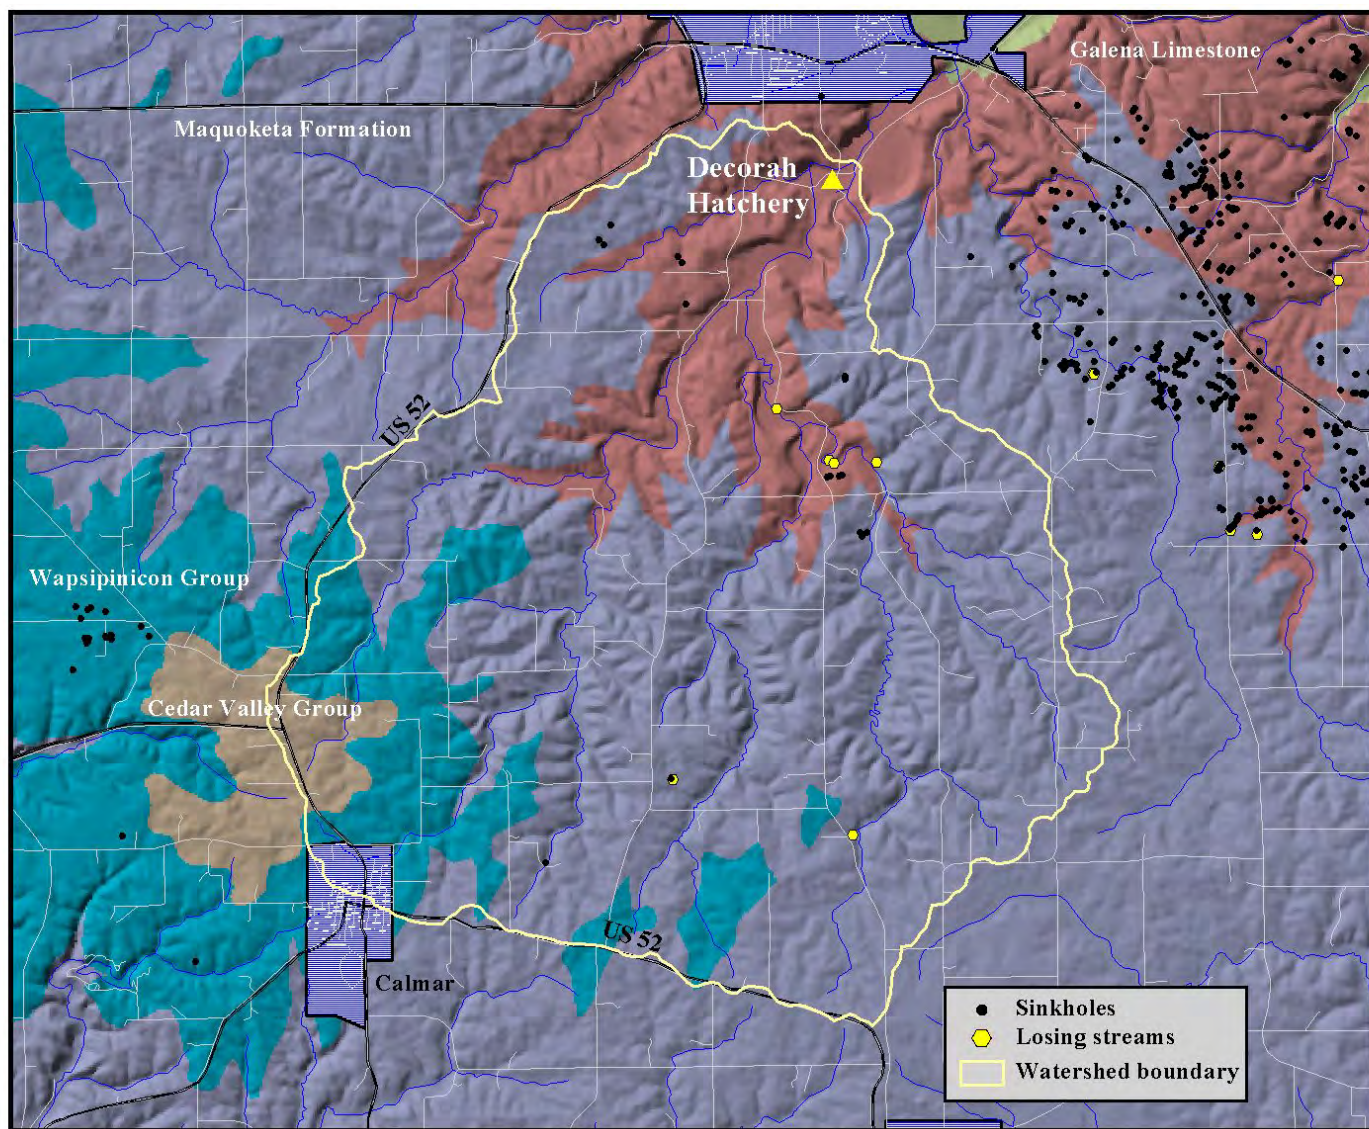
Figure 4-1. Geologic map of the Trout Run watershed area.

The Decorah Hatchery is fed by Siewers Spring, which discharges groundwater from the Galena Limestone to Trout Run Creek. The Trout Run watershed is shown in Figure 4-1. Relatively few sinkholes are shown on the county soil survey for the watershed, although more are known to exist. Losing stream segments have also been observed, some which drain into sinkholes. Many more sinkholes occur in the watershed to the east, and these may contribute water to the spring as well.

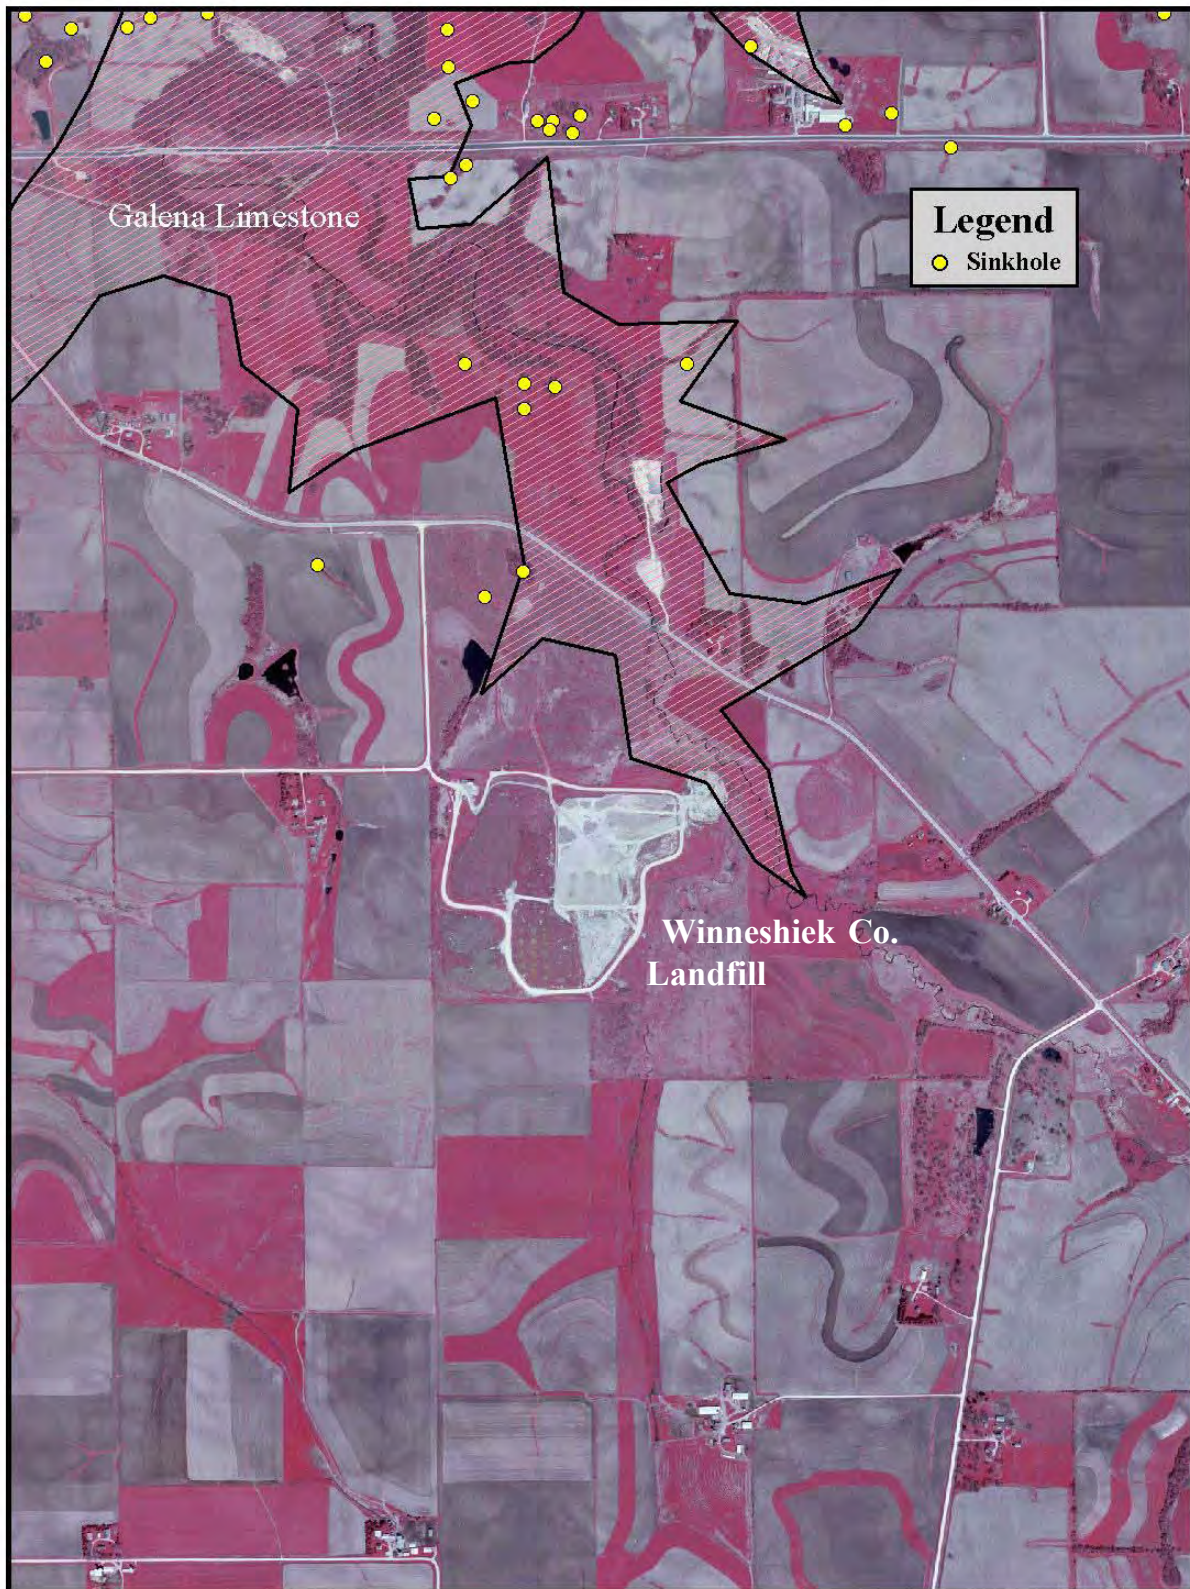
Figure 5-1. Color infrared photo of landfill area.

The Winneshiek County landfill lies within a few miles of some of the most karst-affected areas in the state. We passed sinkholes as we approached the landfill driveway. How can a landfill be in such a setting? Relatively subtle changes in the underlying geology occur as we reach the landfill area. Here, more slowly permeable shale and shaley carbonate rocks of the Maquoketa Formation overlie the Galena Limestone. The Maquoketa rocks are less prone to fracturing and karst formation, although the lowermost part of the formation does exhibit some sinkholes. Also, there is a somewhat greater thickness of glacial deposits here. Taken together, these deposits provide suitable materials for the landfill cells. Figure 5-1 shows the landfill, nearby sinkholes, and the outcrop area of the Galena Limestone.

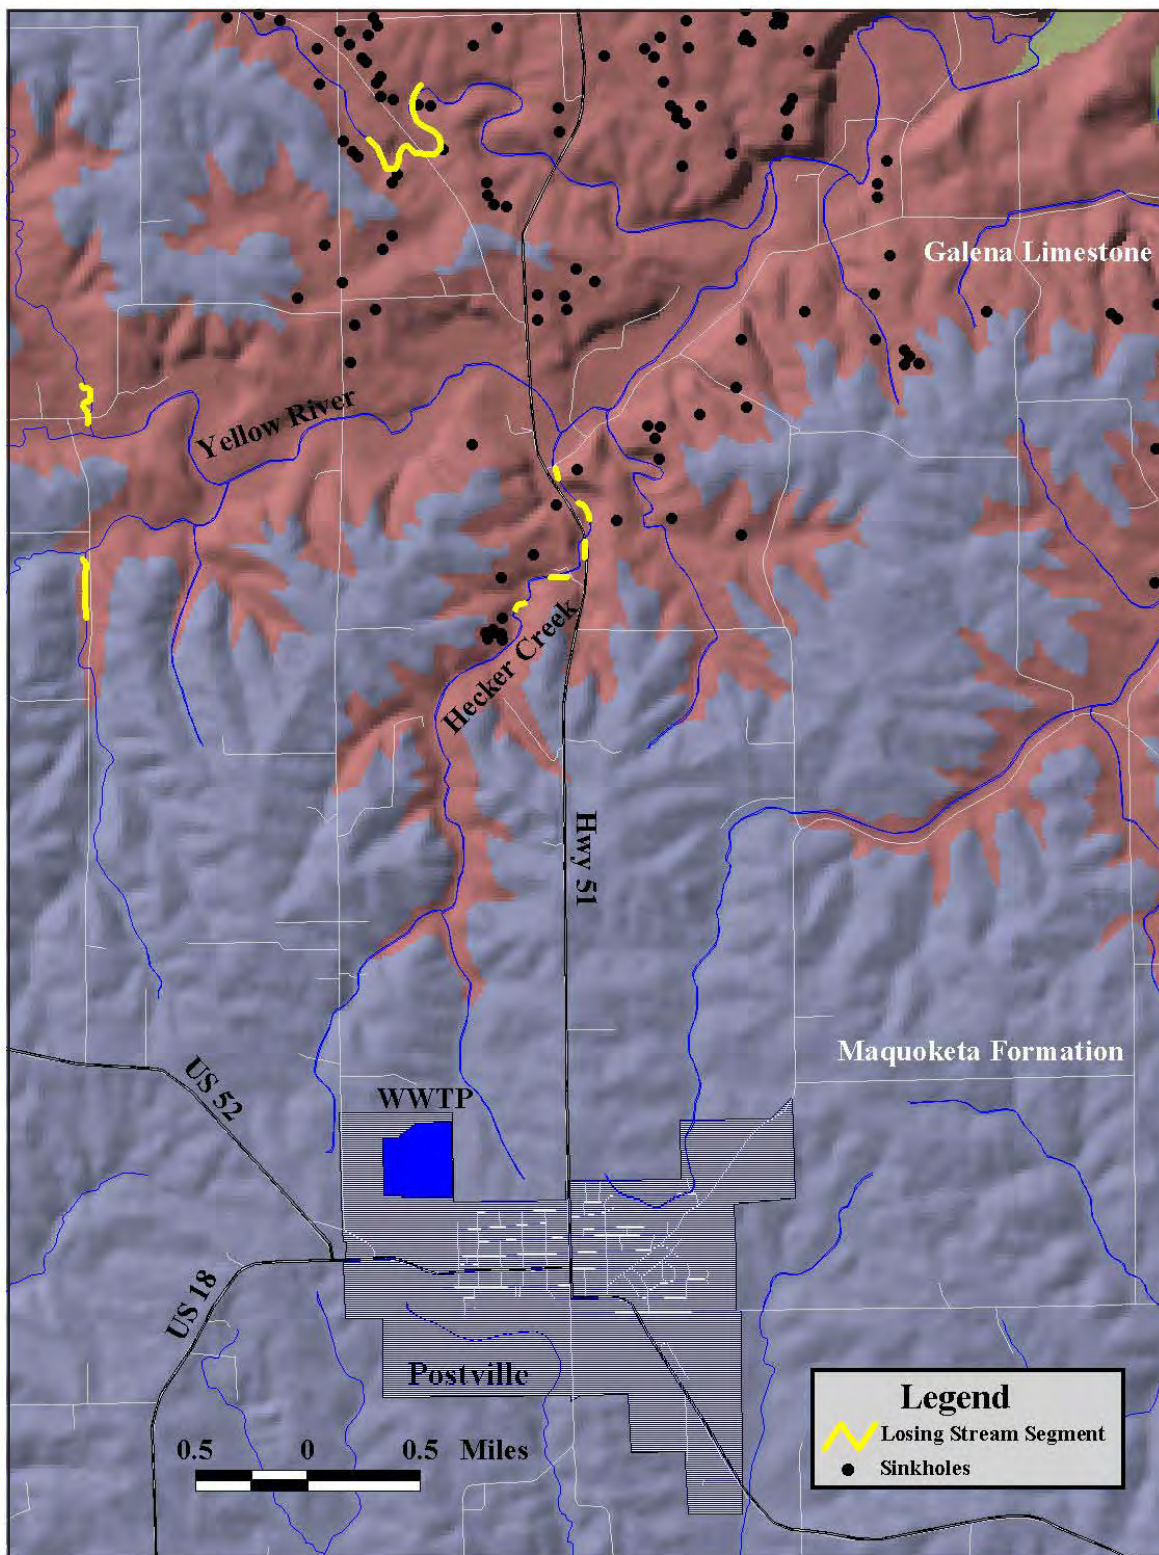
Figure 6-1. Geologic map of the Hecker Creek – Postville area.

Hecker Creek is a tributary of the Yellow River. The creek heads near Postville and joins the Yellow about 5 miles north, just a short distance downstream from this stop. The uppermost part of the watershed is underlain by bedrock of the relatively slowly permeable Maquoketa Formation, and a relatively thick cover of glacial deposits. As the stream flows north, its valley cuts into the underlying karstic Galena Limestone. Where the stream runs over the fractured Galena bedrock, it “loses water” into the rock. During relatively dry conditions, the entire flow disappears into the rock. At this stop we will visit one of the places the stream typically sinks. Figure 6-1 shows the Hecker Creek – Postville area.

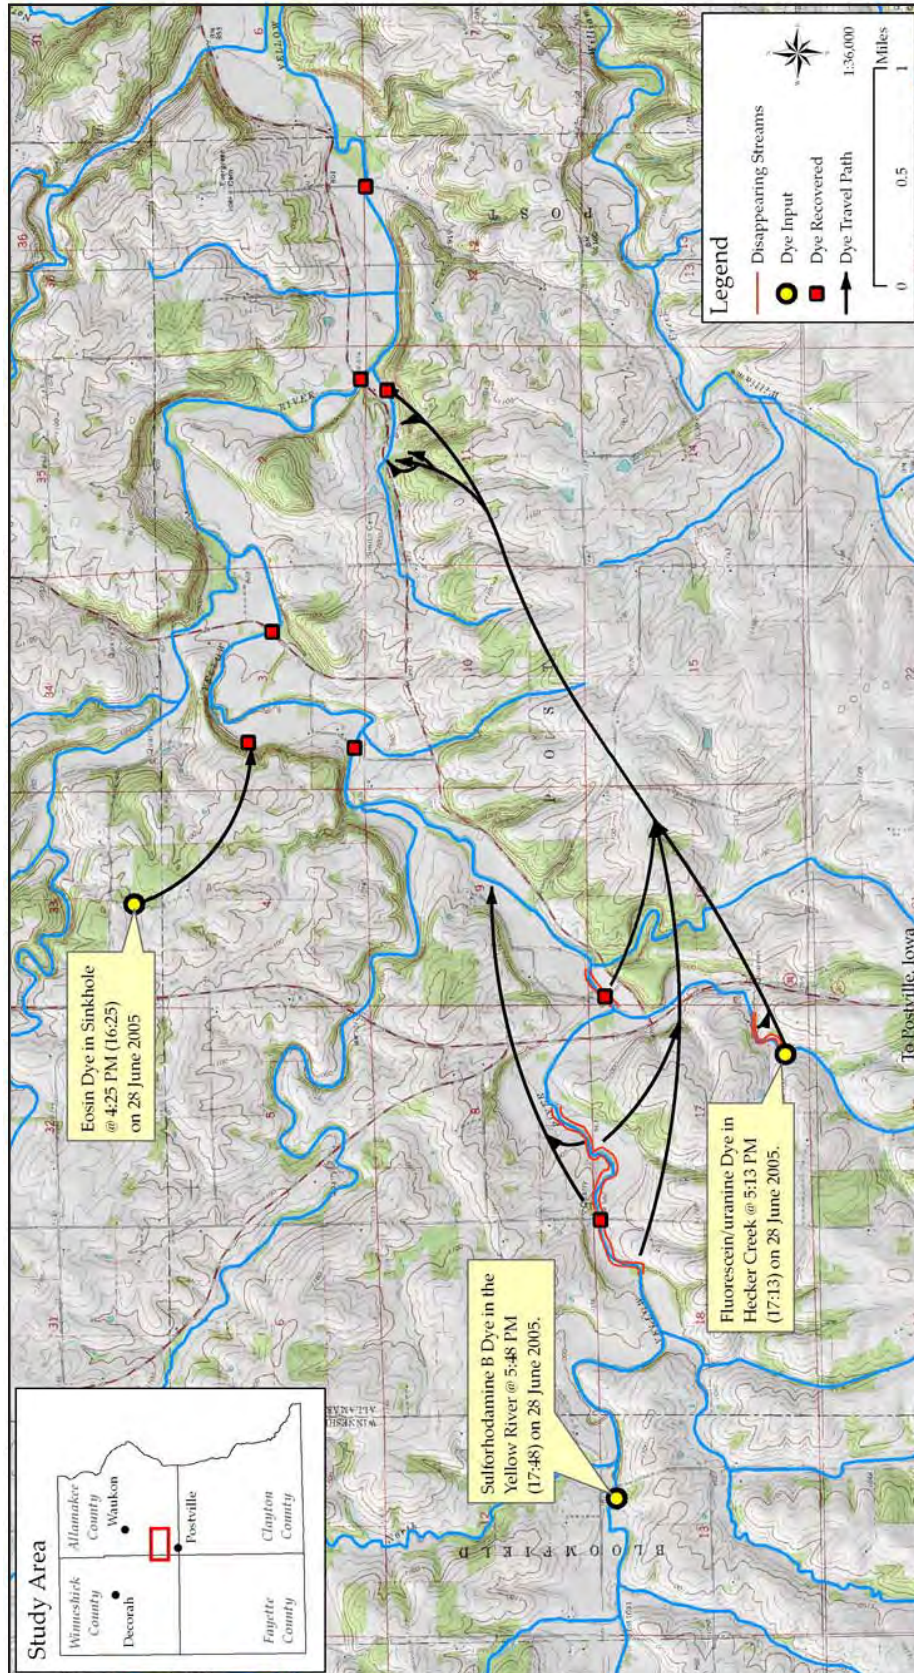
Figure 6-2. Yellow River Watershed dye tracing results.

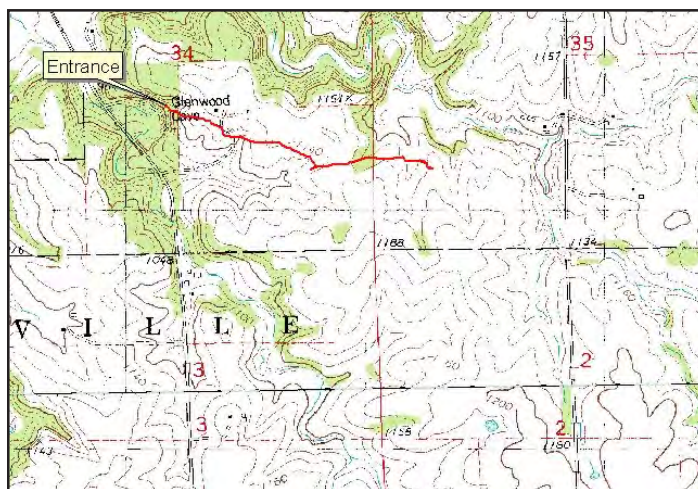
Figure 8-1. Mapped extent (in red) of Glenwood Cave.

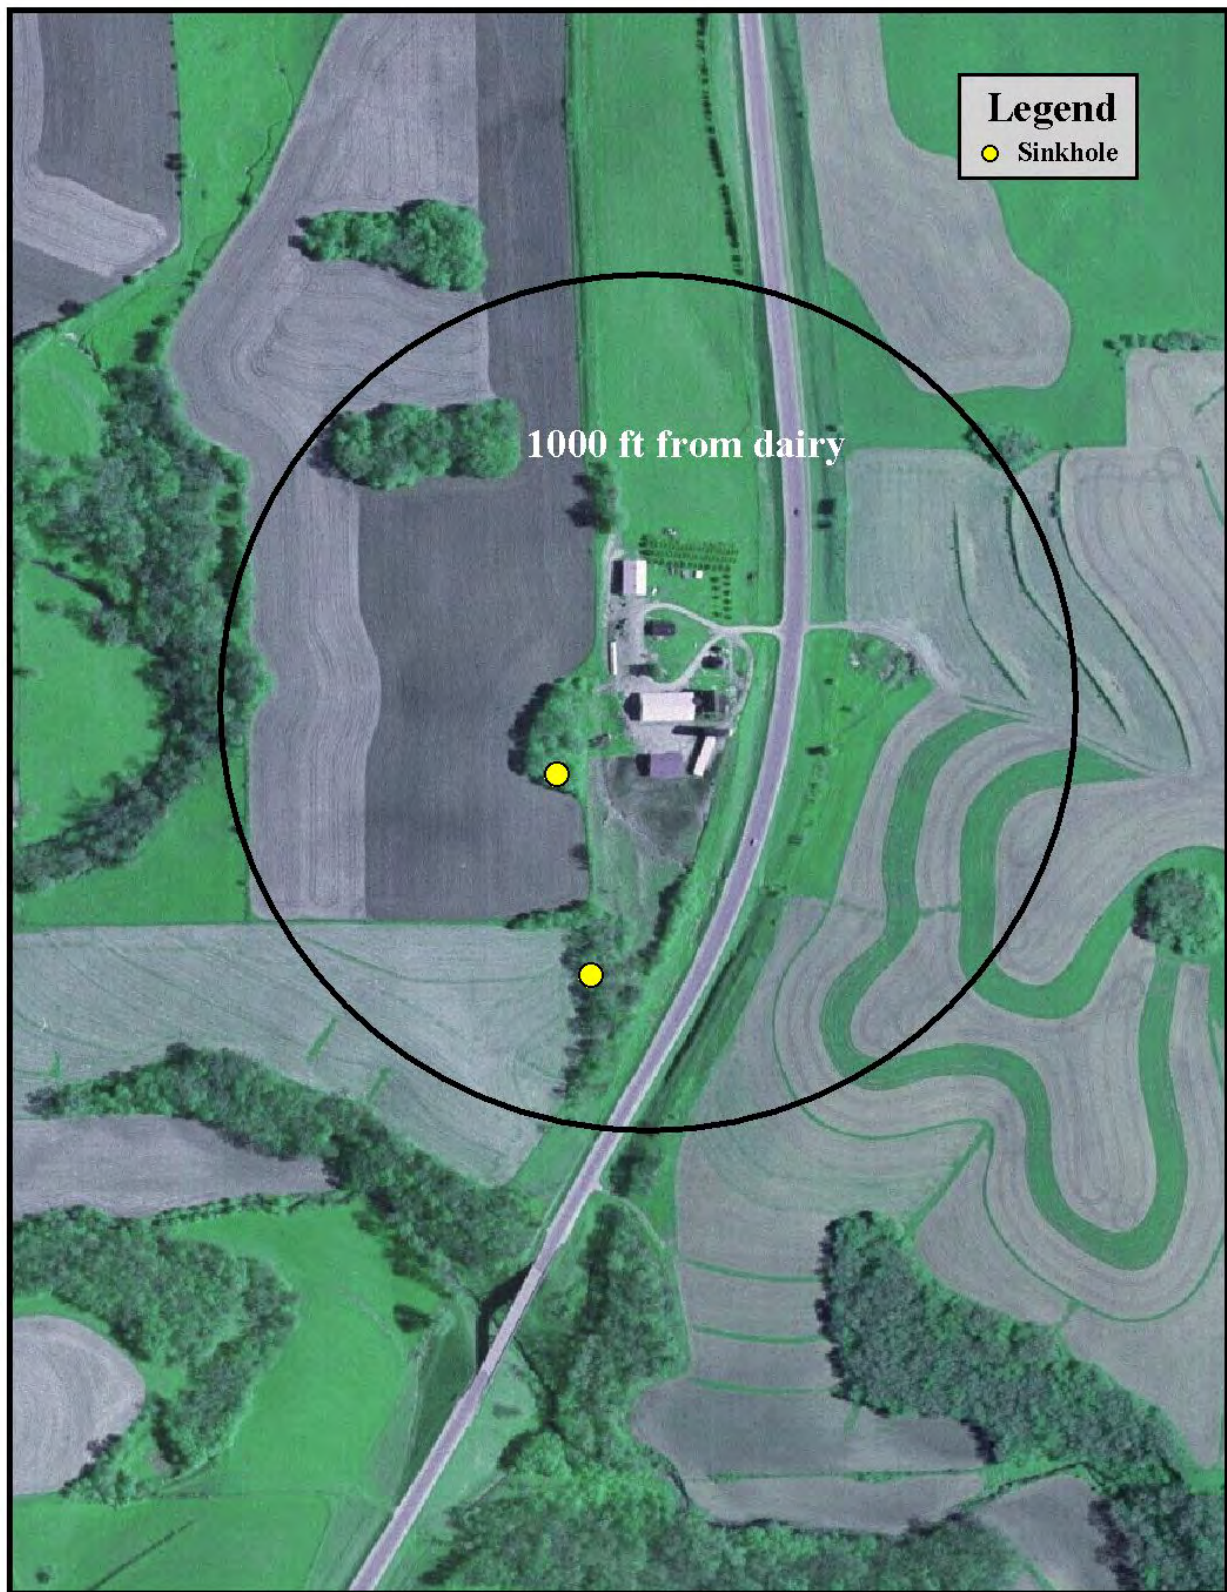
Figure 9-1. Color infrared photo of the Enyart Farm showing sinkholes.

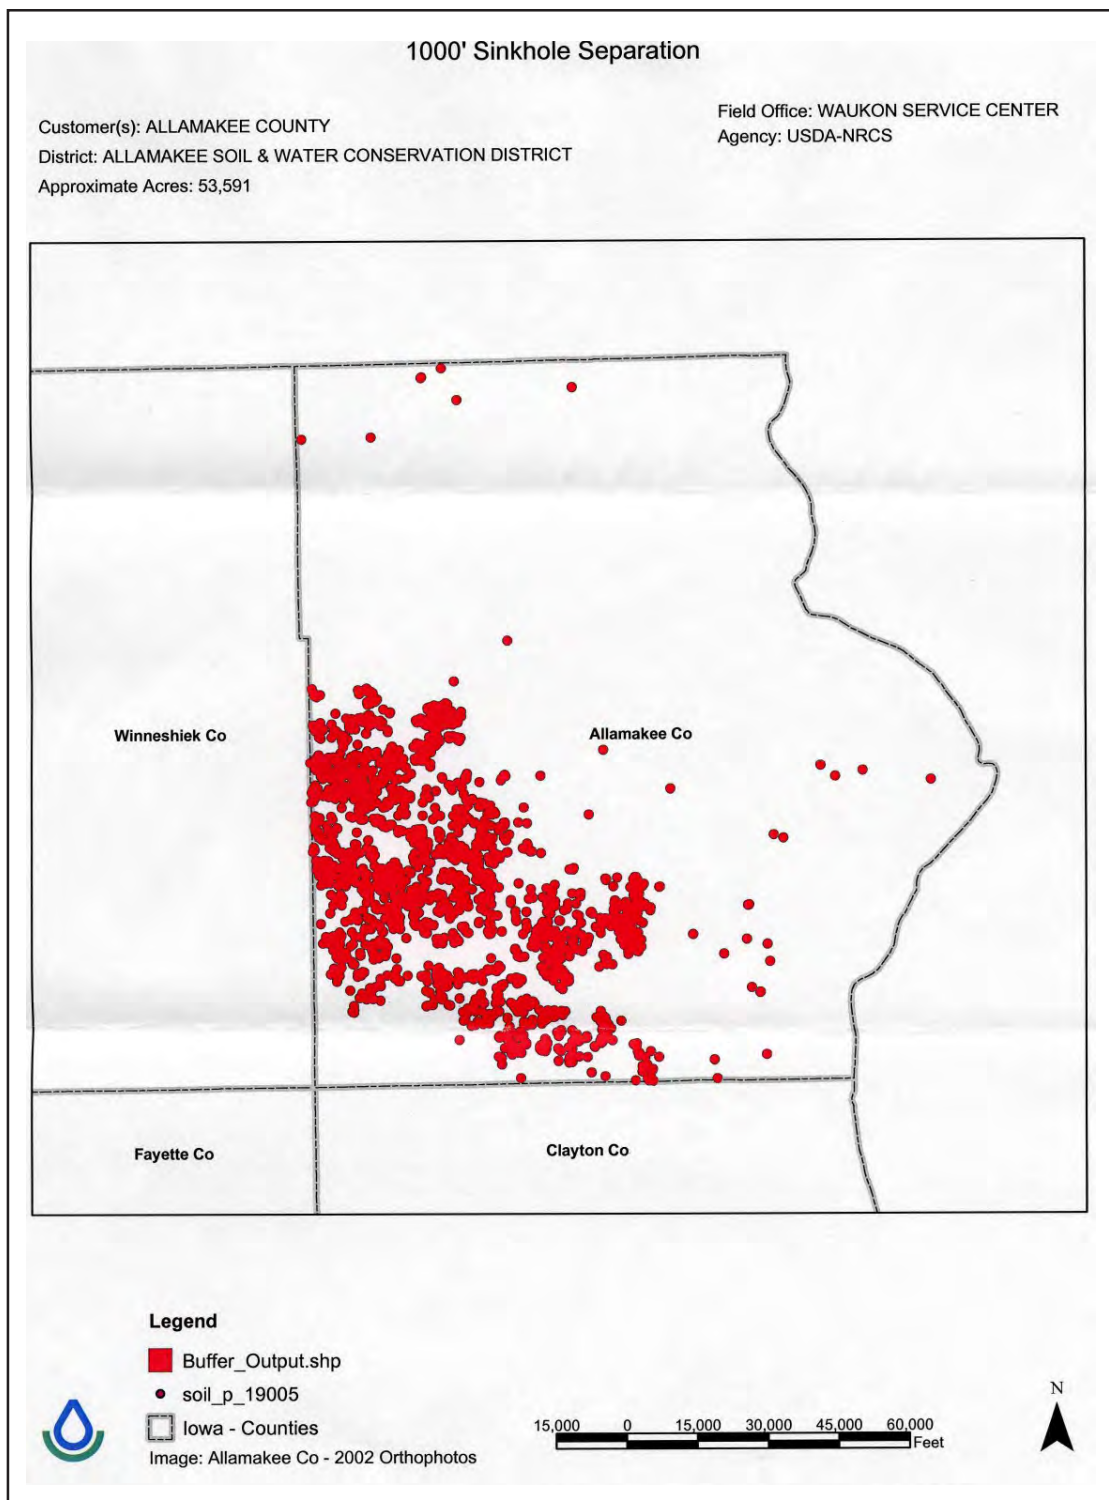
Figure 9-2. Soil Survey sinkholes in Allamakee County.

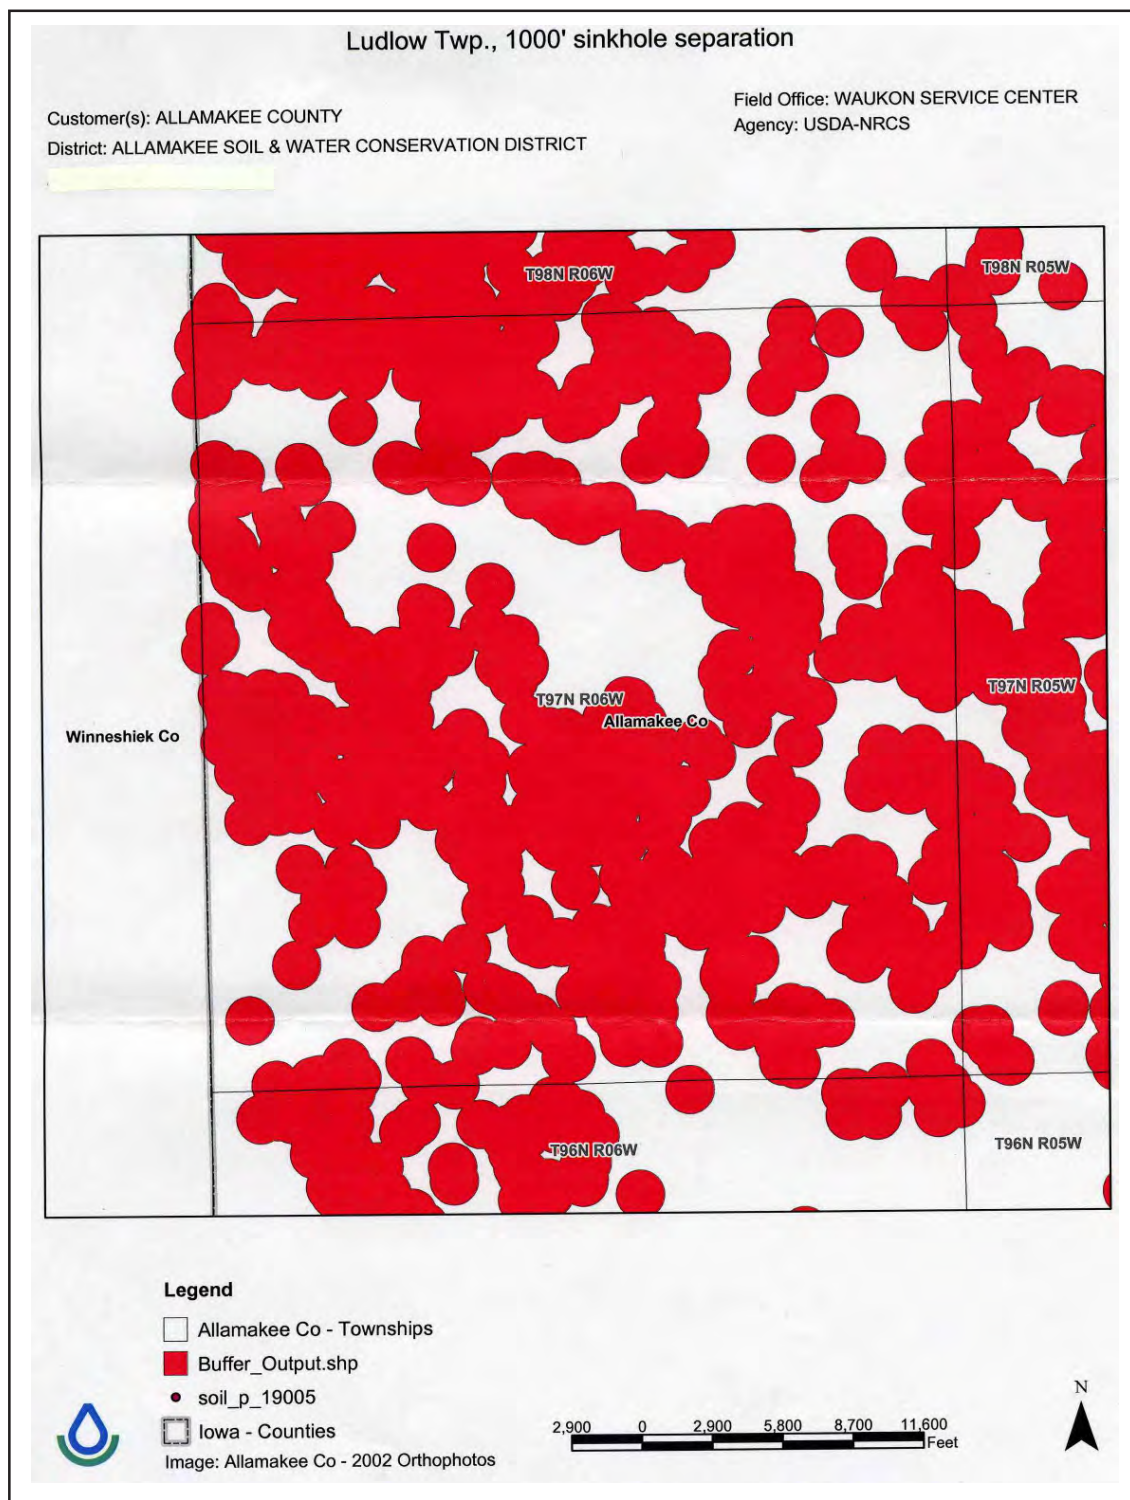
Figure 9-3. Over 75% of the land in Ludlow Township is within 1000 feet of known sinkholes.

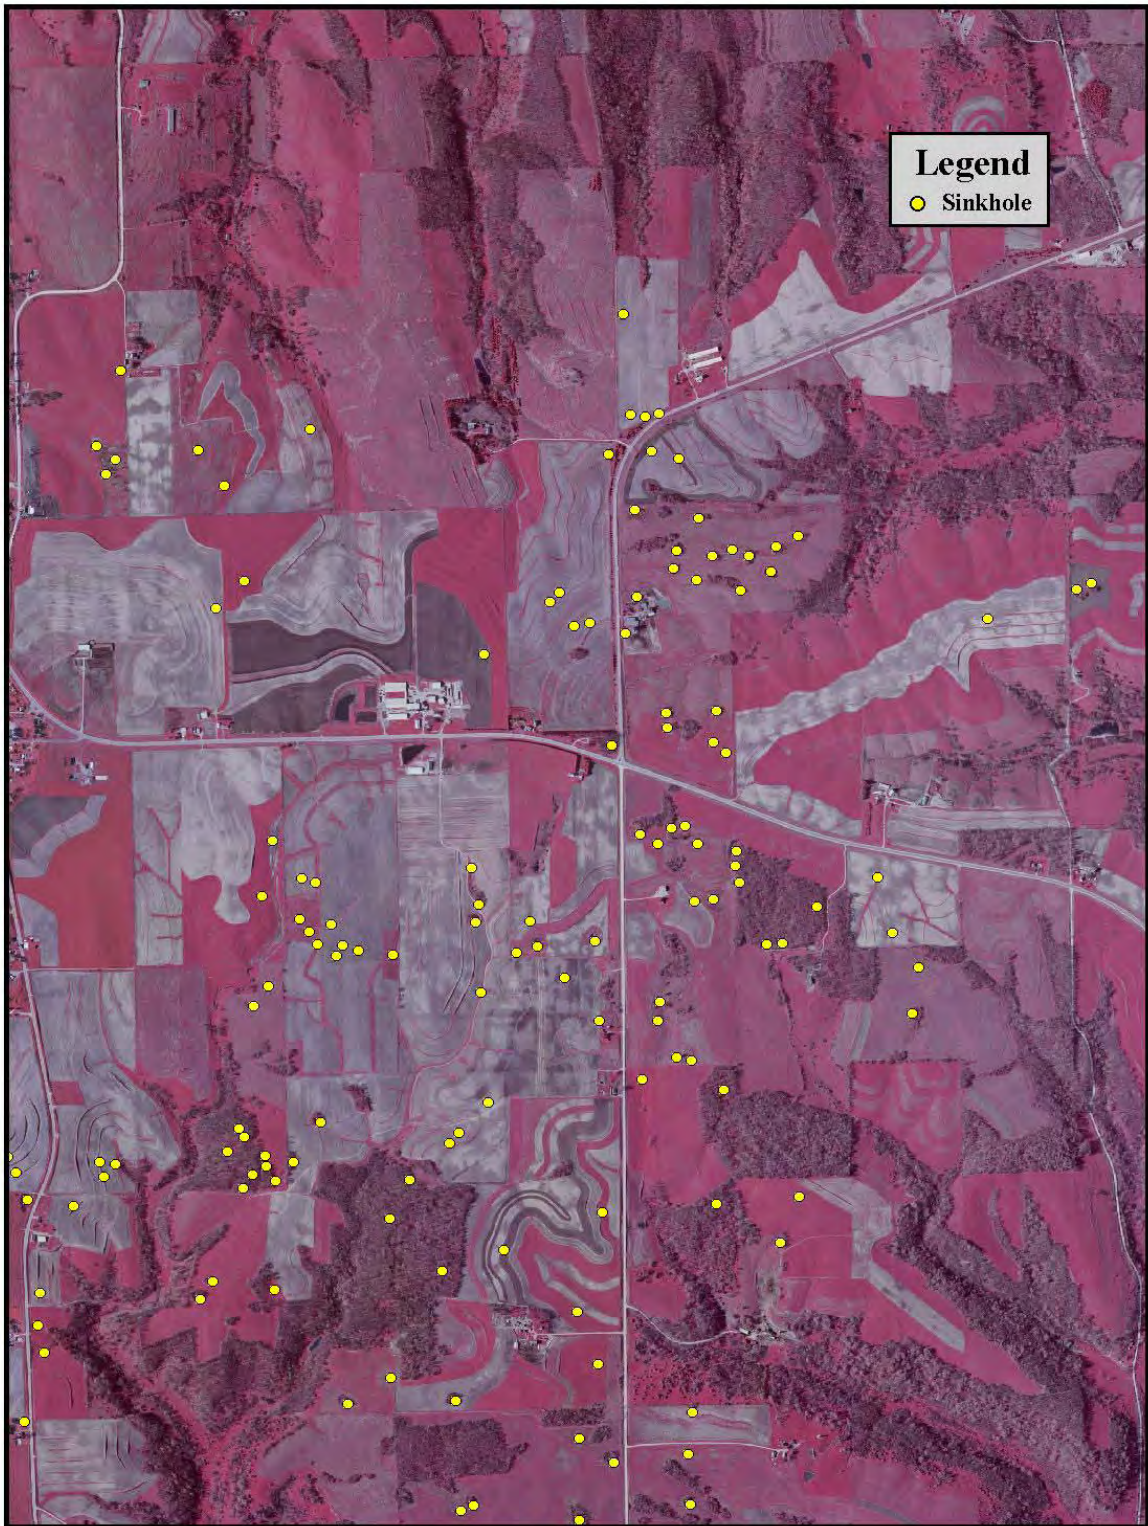
Figure 12-1. Color infrared photo of the Rossville area showing sinkholes.
