LIVING IN KARST

**Iowa Geological Survey
Guidebook Series No. 25**

**IOWA FIELD CONFERENCE FOR PUBLIC POLICY MAKERS
OCTOBER 11-12, 2005**

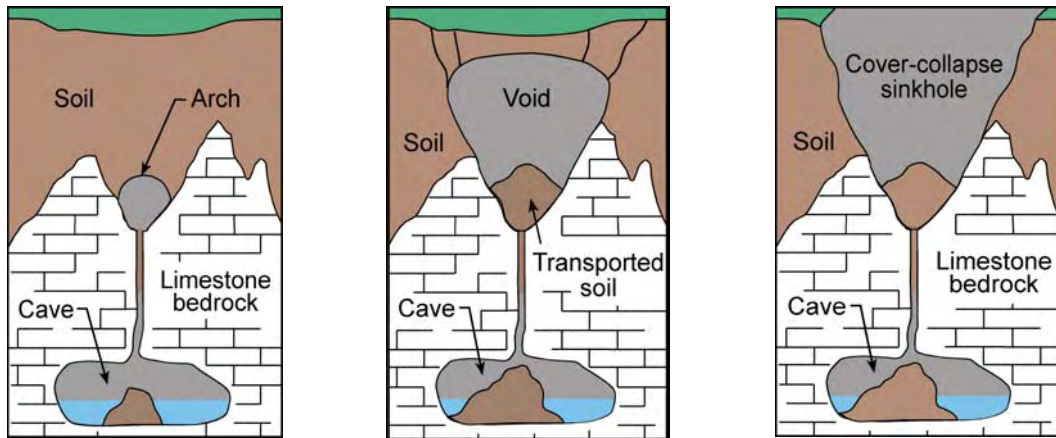
Figure 12-2. Diagram showing steps in sinkhole formation.

Percolating soil water is typically acidic and therefore can dissolve carbonate rocks such as limestone. When near surface fractures and cracks are dissolved into larger voids, the overlying glacial soils may no longer have the strength to bridge the void, and will slowly begin to slump downward. The process of dissolving out voids takes thousands to tens of thousands of years. The failure of surface soils over the void is a much shorter process. It can occur over months to years, or it can occur instantaneously. Figure 12-2 is a schematic depiction of sinkhole formation. Saturated glacial soils will collapse into voids more readily than dry soils. They can flow and ooze into relatively small openings. For this reason, seepage from earthen structures such as lagoons and farm ponds may accelerate collapse, as the seepage keeps the underlying soils permanently saturated. This was the unfortunate case of the Garnavillo sewage lagoon in Clayton County in the early 1980s.

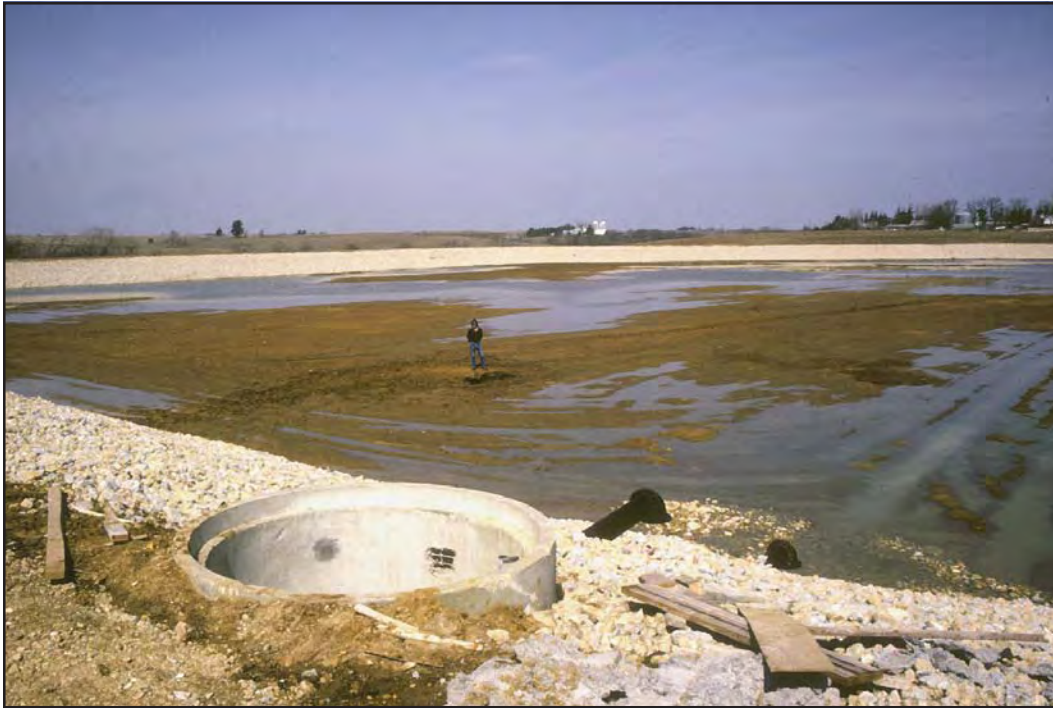
Figure 12-3. City of Garnavillo lagoon after sinkhole failure.

The Garnavillo lagoon system was built as a passive three-cell system, a design easy for the small community to maintain and operate. The cell shown was built into a hillside, with the floor of the lagoon cut to within 5 feet of the Galena Limestone. As the lagoon system was approaching completion, stormwater was directed into this cell to test the seal of the liner, filling the cell to roughly a 1-2 foot depth. This occurred on a Friday afternoon. By Monday morning, a sinkhole had formed and the lagoon was dry (Figures 12-3 and 12-4). Over the coming months a line of small depressions formed in the cell. Ultimately, this cell and a second were abandoned. The third cell, which overlies a thicker cover of glacial materials, was converted to an aerated system. This was a less simple design than the city had planned on, but it was a retrofit that would work.

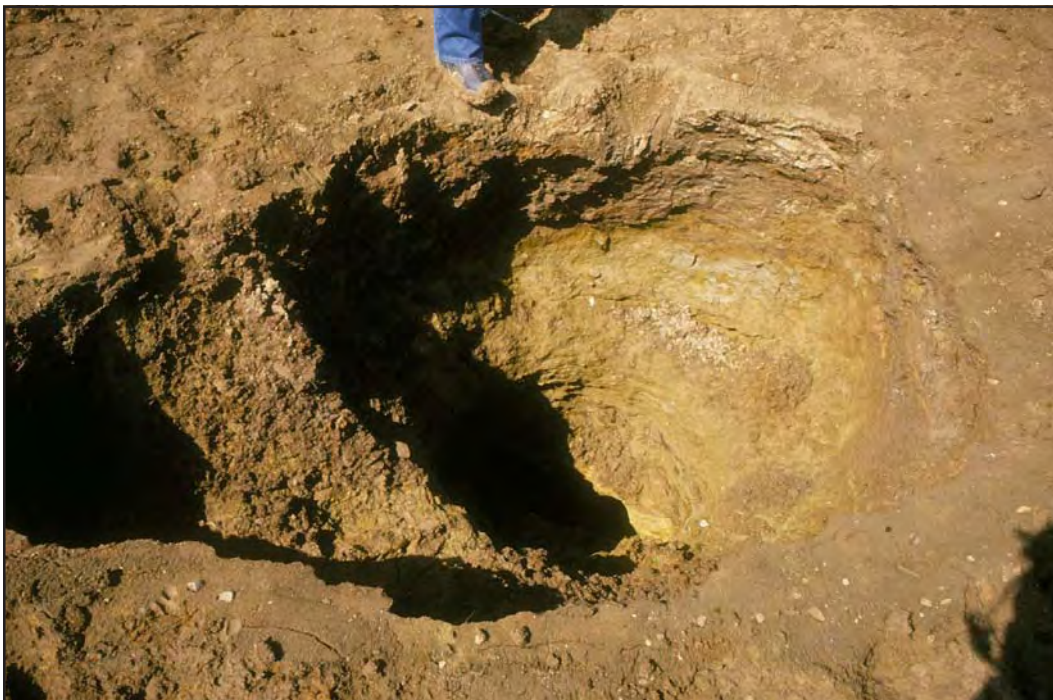
Figure 12-4. Close-up of sinkhole at city of Garnavillo lagoon.

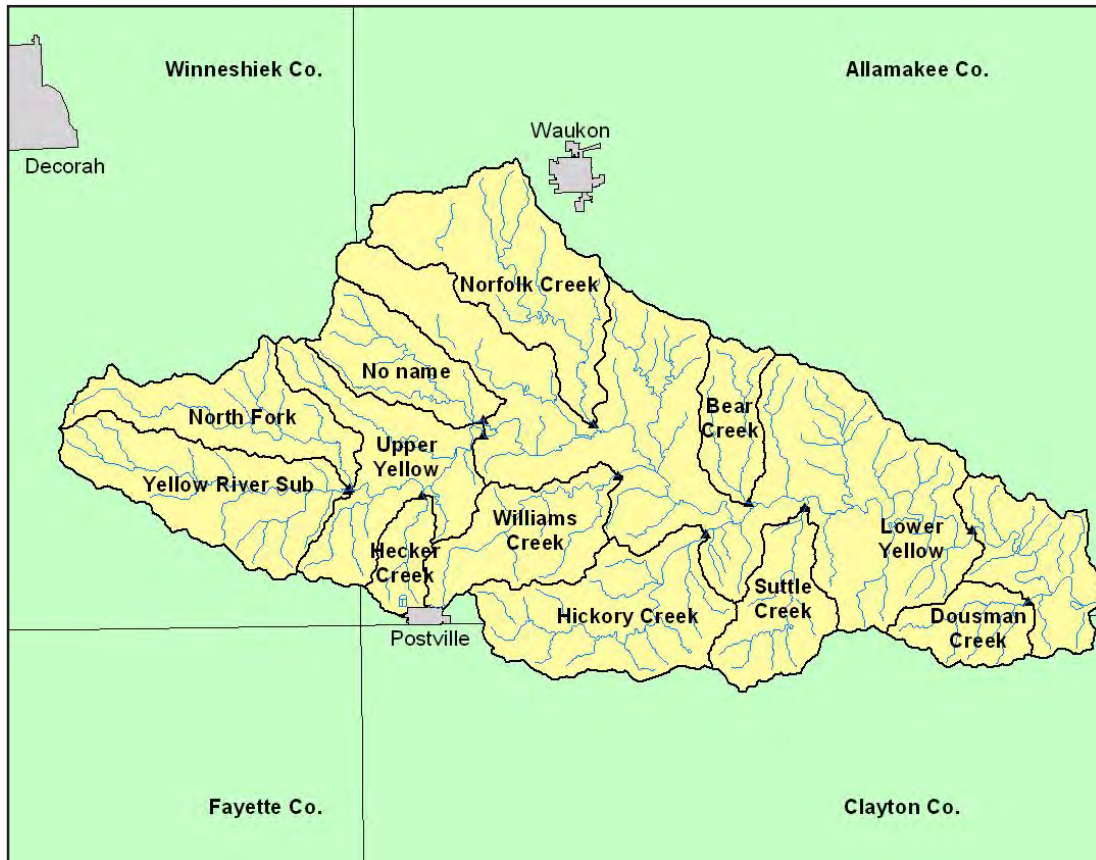
Figure 13-1. Monitoring locations and subwatersheds in the Yellow River Basin.

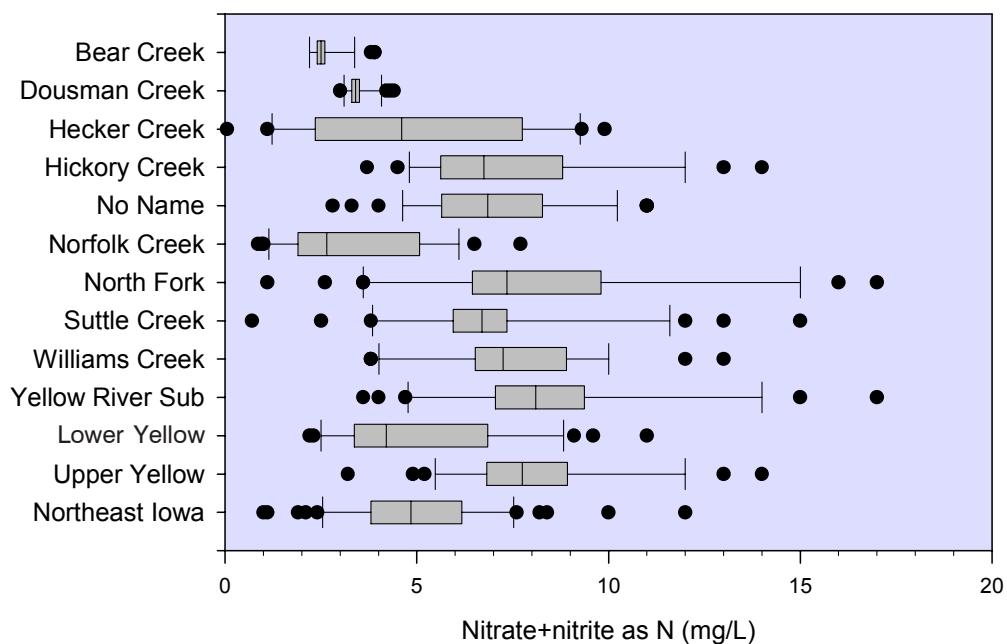
Figure 13-2. Nitrate+nitrite-N concentrations for the Yellow River and northeast Iowa streams.

Nitrate+nitrite-N is an inorganic form of nitrogen in Iowa's streams and groundwater. Nitrogen is a necessary nutrient for plant growth. Excess nitrogen in surface waters, however, can contribute to nutrient enrichment, increasing aquatic plant growth and changing the types of plants and animals that live in a stream. The maximum allowable level of nitrate-N in drinking water is 10 mg/L. Sources of nitrogen include cultivated soils, human and animal wastes, decomposing plants, and fertilizers. Most nitrate is "leached" from soils by infiltrating soil waters. Figure 13-2 shows nitrate+nitrite-N concentrations for the Yellow River area.

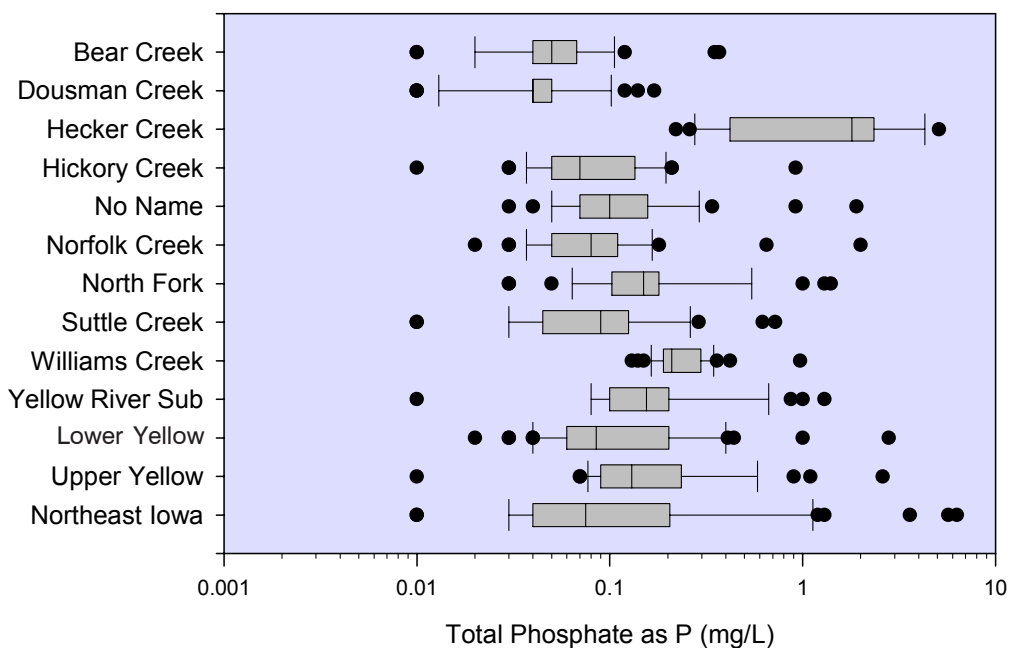
Figure 13-3. Total Phosphate-P concentrations for the Yellow River and northeast Iowa streams.

Total phosphate-P is a measure of all dissolved and particulate forms of phosphate in water. Phosphorus is a necessary nutrient for plant growth and generally is limiting in the freshwater environment. Too much phosphorus in surface waters, however, can contribute to nutrient enrichment, increasing aquatic plant growth, and changing the types of plants and animals that live in a stream. Sources of phosphorus include certain soils and bedrock, human and animal wastes, decomposing plants, and runoff from fertilized lawns and cropland. Figure 13-3 shows total phosphate-P for the watershed sites.

Total phosphate-P concentrations ranged from <0.02 mg/L to 5.1 mg/L in the Yellow River watershed. Median concentrations clustered around 0.1 mg/L. With the exception of the Hecker Creek site, the total phosphate-P concentrations throughout the watershed were similar to those reported from other northeast Iowa streams. In general, watersheds with higher percentages of row crops had higher median total phosphate-P concentrations.

However, several high total phosphate-P results at the Hecker Creek and Upper Yellow sites were associated with discharges from the Postville-Agri Processors industrial lagoon.

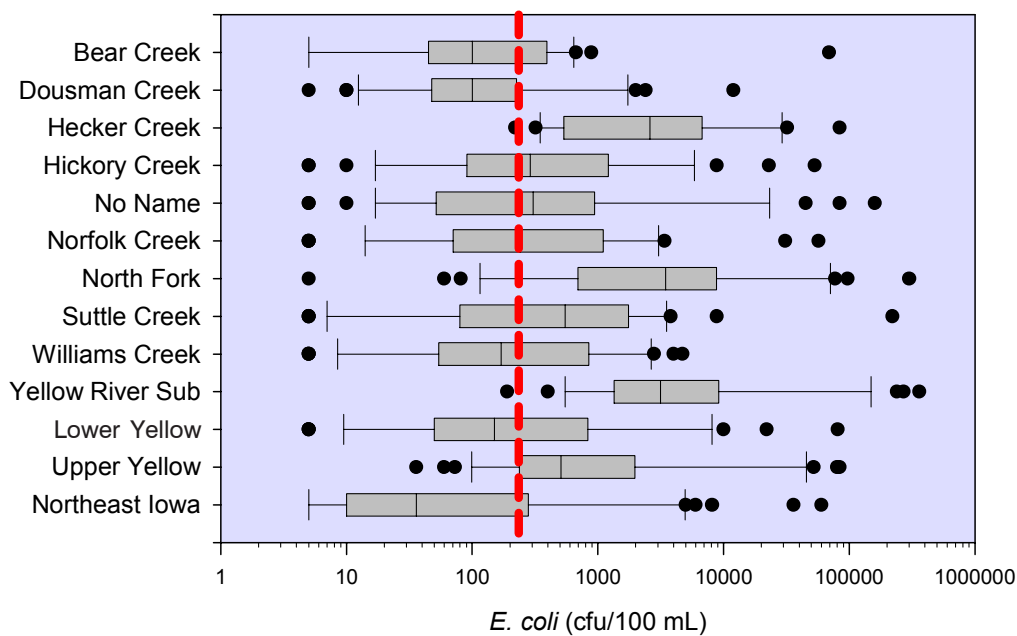
Figure 13-4. *E. coli* concentrations for the Yellow River and northeast Iowa streams. Dashed red line shows Iowa's one-time maximum *E. coli* standard.

Escherichia coli (*E. coli*) bacteria are a type of coliform bacteria present in the gastrointestinal tract of warm-blooded animals. *Escherichia coli* is called an “indicator bacteria,” meaning they do not cause illness, but their presence suggests that disease-causing organisms (pathogens) may be present. As the number of indicator bacteria rises in water, so does the likelihood that pathogens are present. The most frequent sources of pathogens are sewage overflows, malfunctioning septic systems, animal waste, polluted storm water runoff, and boating wastes. The presence of *E. coli* bacteria suggests that a pathway exists for a relatively fresh source of human or animal waste to enter the stream. Figure 13-4 shows *E. coli* concentrations for the watershed sites.

The *E. coli* concentrations ranged from <10 to 360,000 colony forming units (CFU)/100 mL. If all the streams in the watershed were classified as “swimmable,” all the streams would exceed the State of Iowa’s one-time maximum *E. coli* standard (235 CFU/100 mL). Many of the monitored sites in the Yellow had median concentrations exceeding this level. High *E. coli* results at the North Fork and Yellow River Subwatershed sites occurred on the days that also had high rainfall and high ammonia-N concentrations, which may indicate that these problems were caused by manure entering the streams. These watersheds, and Hecker Creek, had the highest median *E. coli* levels.

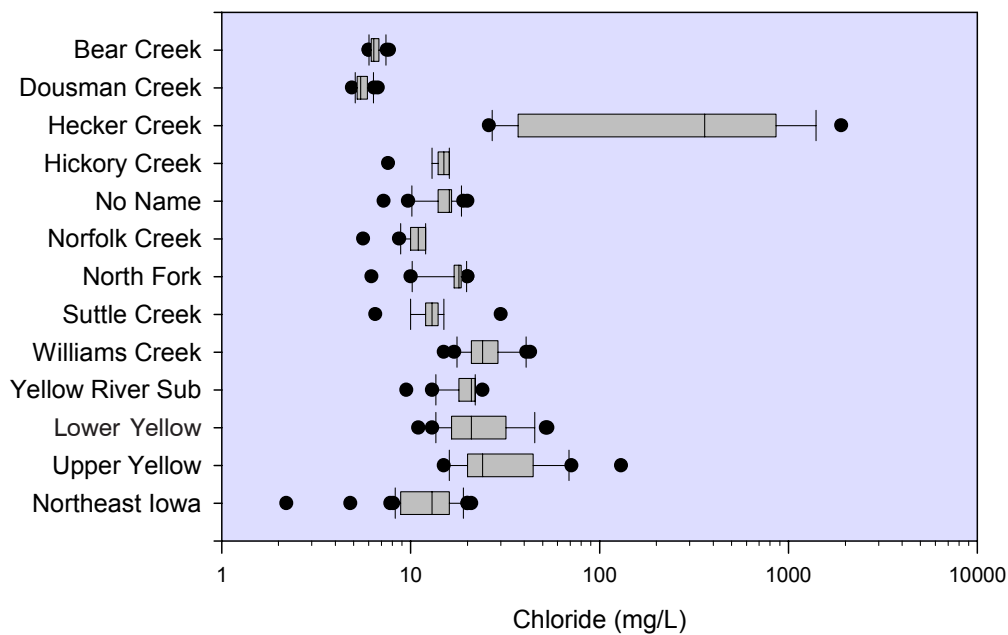
Figure 13-5. Chloride concentrations for the Yellow River and northeast Iowa streams.

Chloride ranged from 4.9 to 1,900 mg/L in the Yellow River watershed. Chloride data from other water monitoring stations showed median chloride levels typically below 25 mg/L across northeast Iowa. Two sites in the Yellow River watershed, Hecker Creek and the Upper Yellow River, had chloride values that routinely exceeded 25 mg/L. For both sites, high chloride values were associated with discharges from the Postville-Agri Processors industrial lagoon.

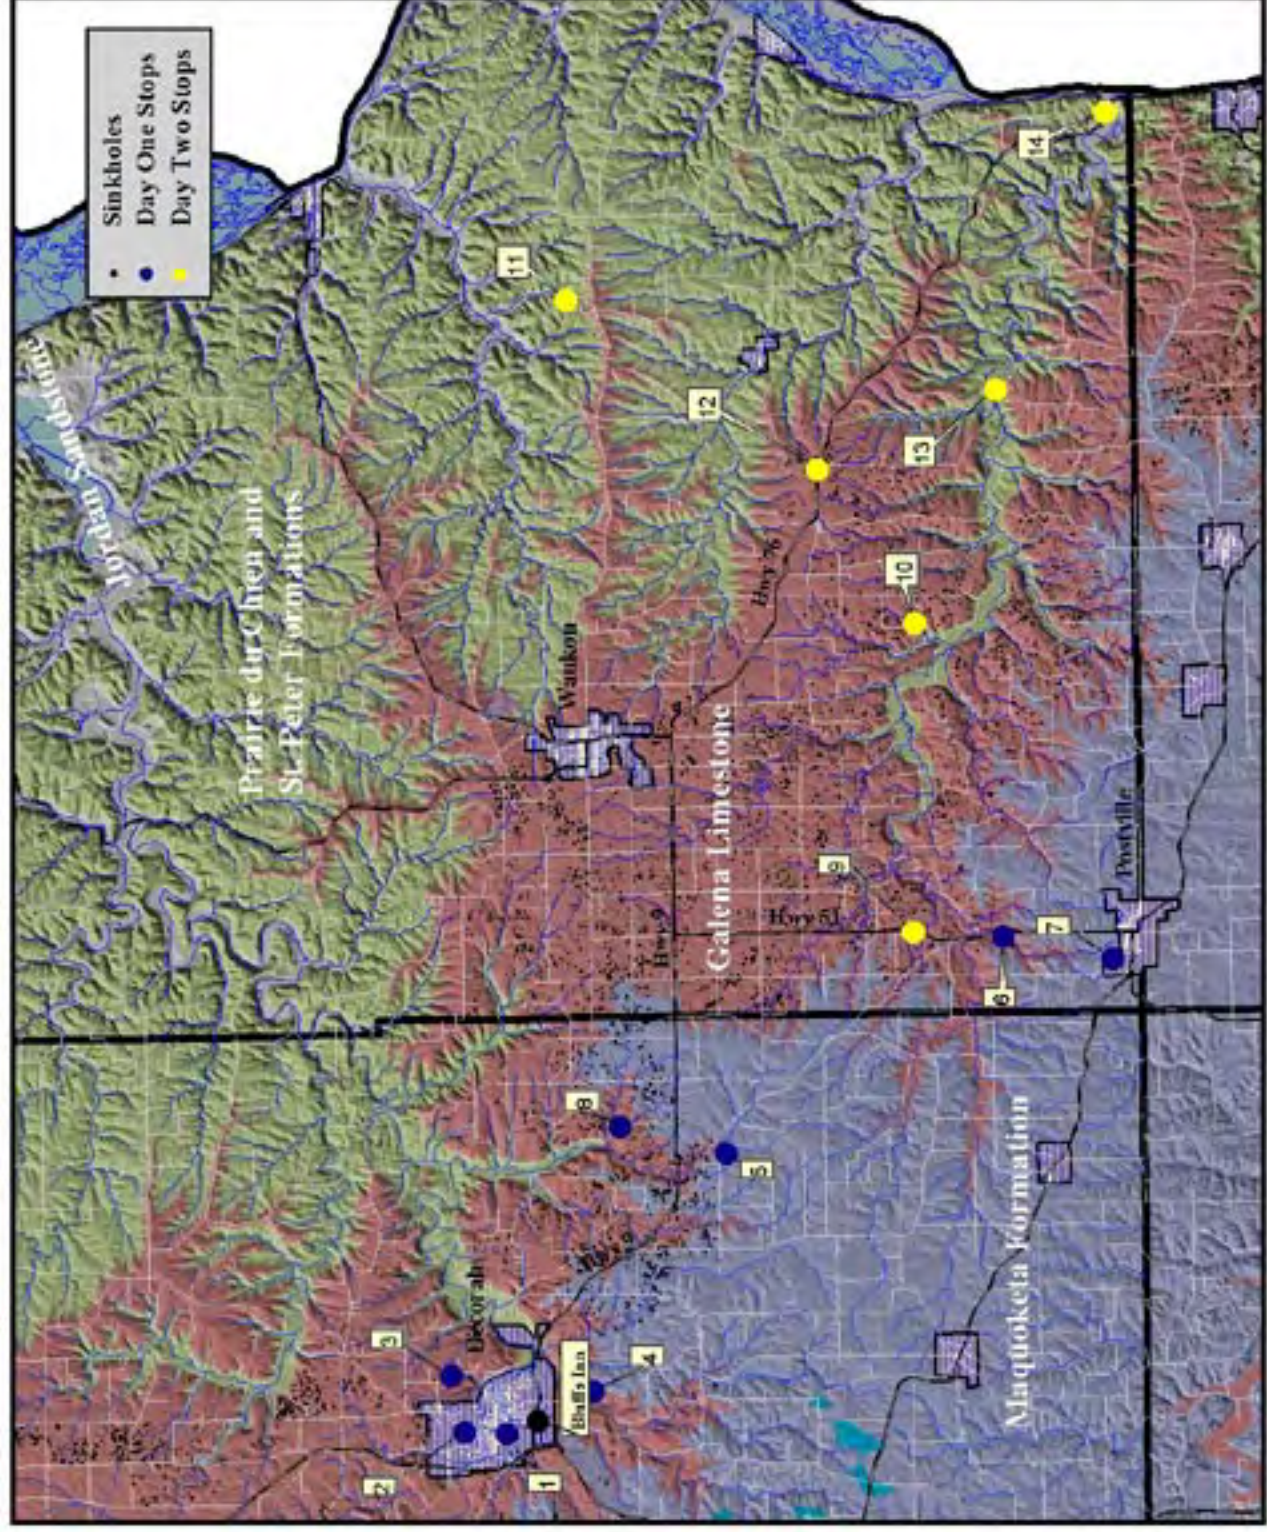
Generalized geologic map of northeast Iowa showing field conference stops.
